**NIST NCSTAR 1**

Federal Building and Fire Safety Investigation  
of the World Trade Center Disaster

# **Final Report** on the **Collapse of the World Trade Center Towers**

September 2005

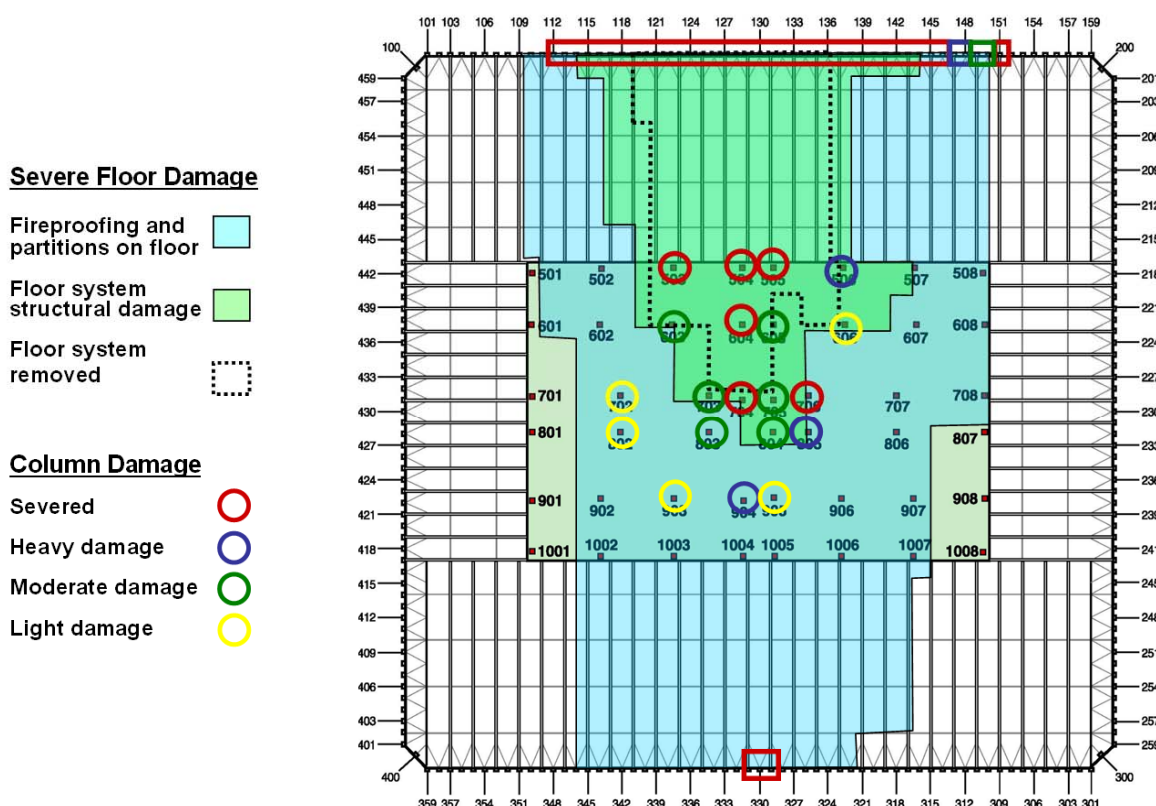
- 43 of 47 core columns stripped of insulation on one or more floors.
- Insulation stripped from trusses covering 60,000 ft<sup>2</sup> of floor area.

**Figure 2-4. Simulation of cumulative aircraft impact damage to floors 93 through 98 in WTC 1.**

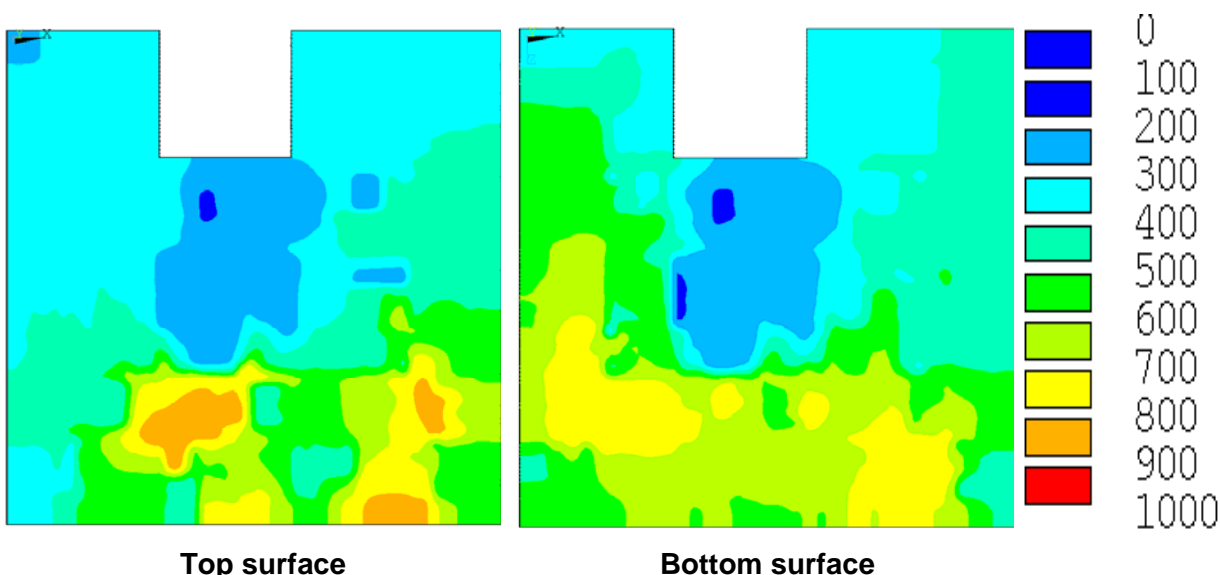
Simultaneously, the fires were creating another problem for the tower. The floors of the 93<sup>rd</sup> through the 97<sup>th</sup> stories were being heated both by the hot gases from below and by thermal radiation from the fires on the floor above (Figure 2–11). On the south side of the building, where the fires were heating the long-span trusses whose SFRM had been dislodged, the floors began to sag. In so doing, they began pulling inward on their connections to the south face and to the core columns. Pull-in forces due to the sagging floors did not fail the floor connections in most areas.

**Figure 2-11. Temperature contours (°C) on the top and bottom faces of the concrete slab (96<sup>th</sup> floor, WTC 1) at 100 min after impact. A portion of the concrete slab on the north face (top) was damaged by the impact of the aircraft.**

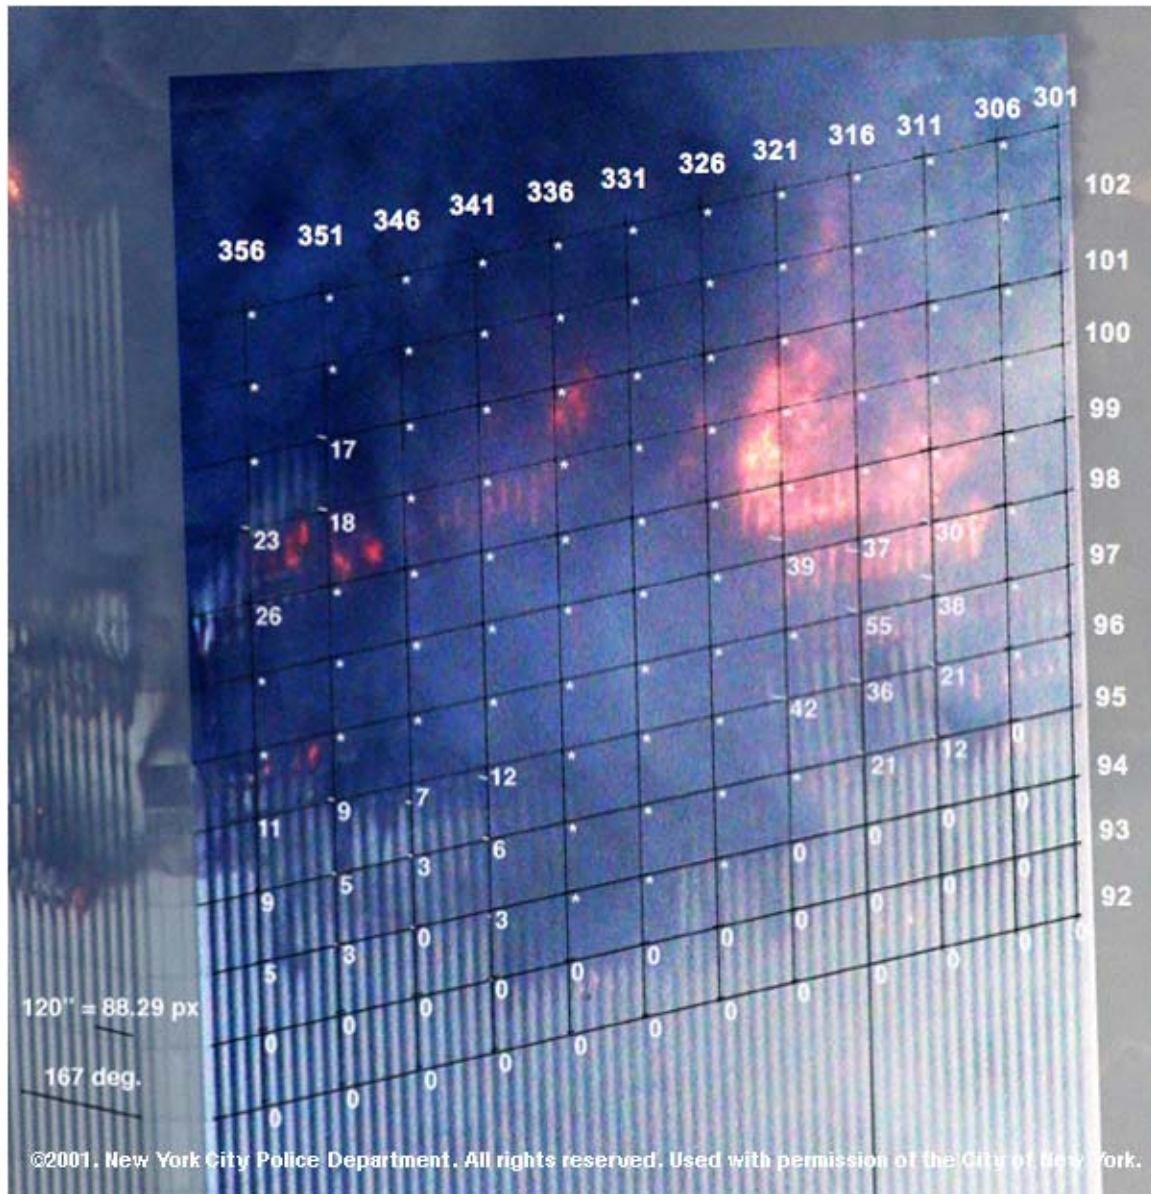
The sagging of the floors had increased. Although the floors on the north side of the tower had sagged first, they contracted due to cooling when the fires moved toward the south. Now, the south side floors had sagged to the point where the south perimeter columns bowed inward (Figure 2–12). By 10:23 a.m., the south exterior wall had bowed inward as much as 55 in.

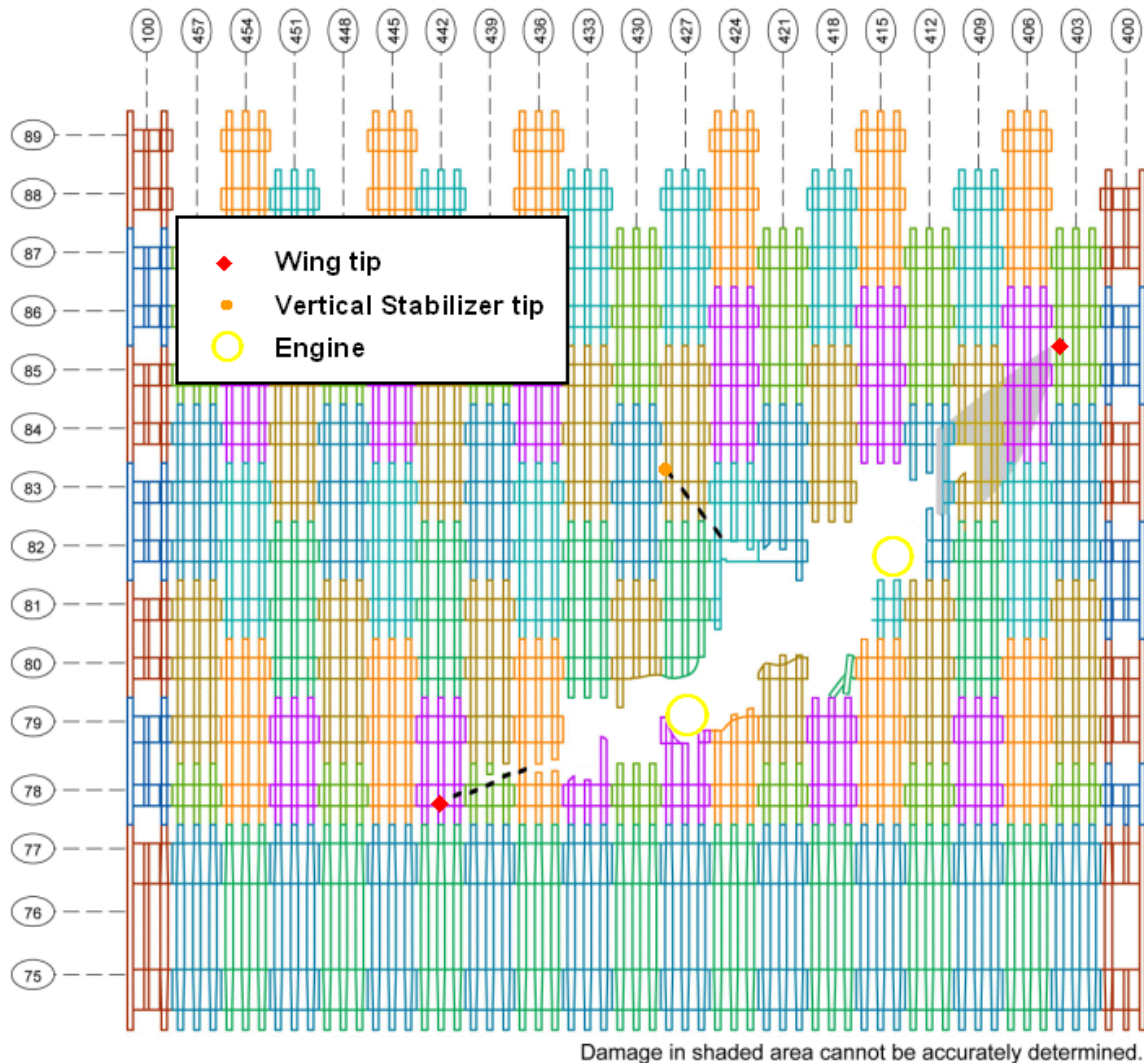
bank angle was steeper than that of AA Flight 11, this entry wound stretched over nine floors, from 77 to 85, rather than eight in WTC 1 (Figure 3–2). The occupancy of those floors is shown in Table 3–1.

Figure 3–2. South face damage of WTC 2 with key aircraft component locations marked.

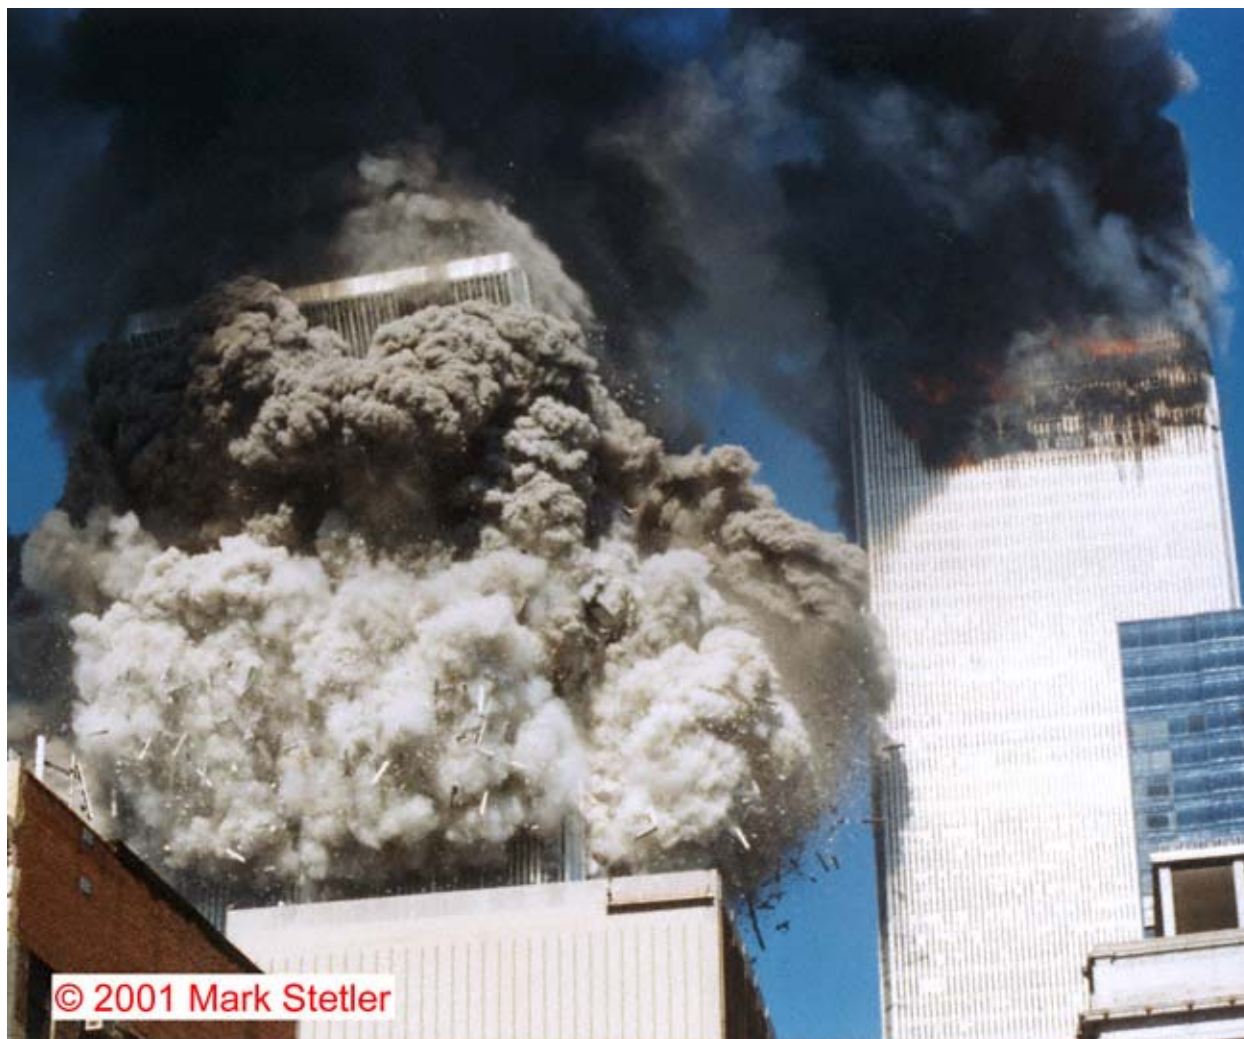
The physical condition of the tower had deteriorated seriously. The inward bowing of columns on the east wall spread along the east face. The east wall lost its ability to support gravity loads, and, consequently, redistributed the loads to the weakened core through the hat truss and to the adjacent north and south walls through the spandrels. But the loads could not be supported by the weakened structure, and the entire section of the building above the impact zone began tilting as a rigid block to the east and south (Figure 3–5). Column failure continued from the east wall around the corners to the north and south faces. The top of the building continued to tilt to the east and south, as, at 9:58:59 a.m., WTC 2 began to collapse.

**Figure 3–5. Photograph of WTC 2 tilting to the southeast at the onset of collapse.**

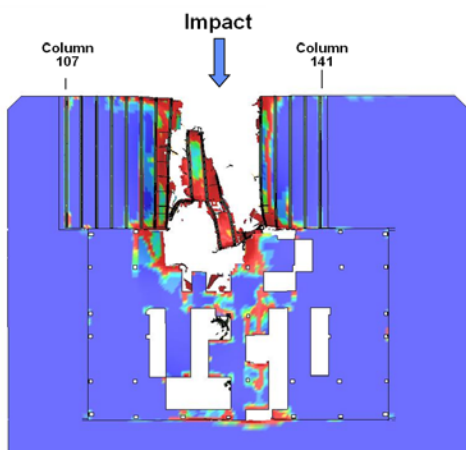
**Figure 6–20. Case B damage to the slab of floor 96 of WTC 1.**

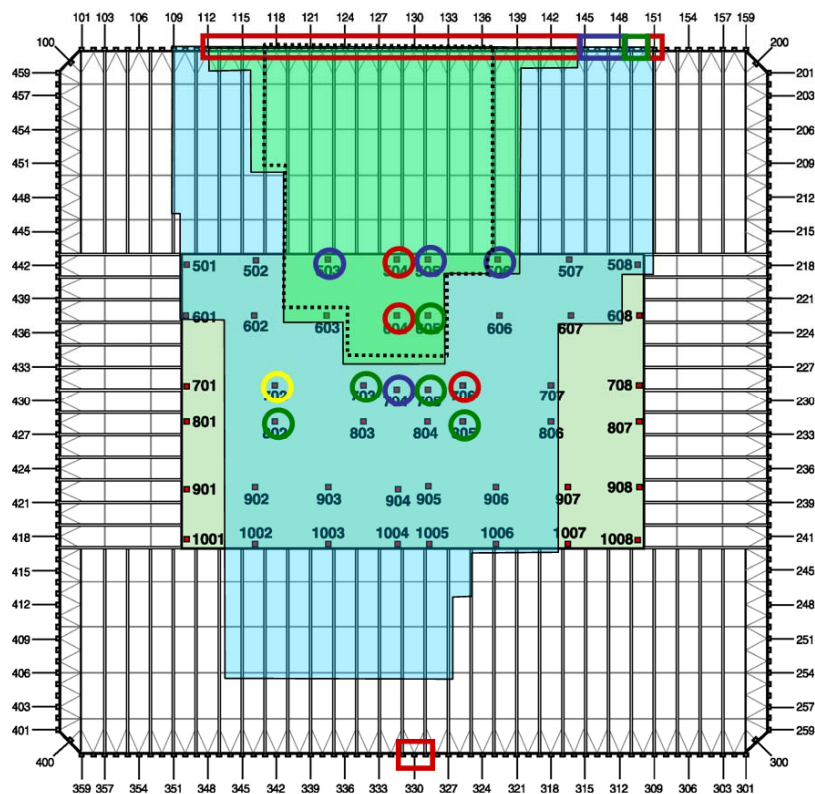
Figure 6-22. Combined structural damage to the floors and columns of WTC 1, Case A.

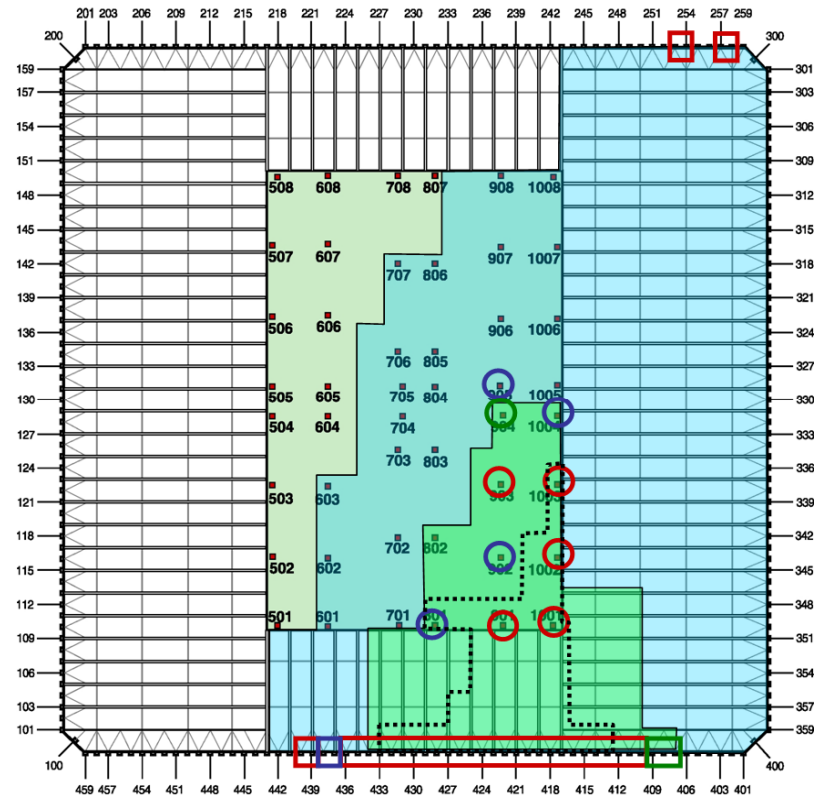
Figure 6–24. Combined structural damage to the floors and columns of WTC 2, Case C.

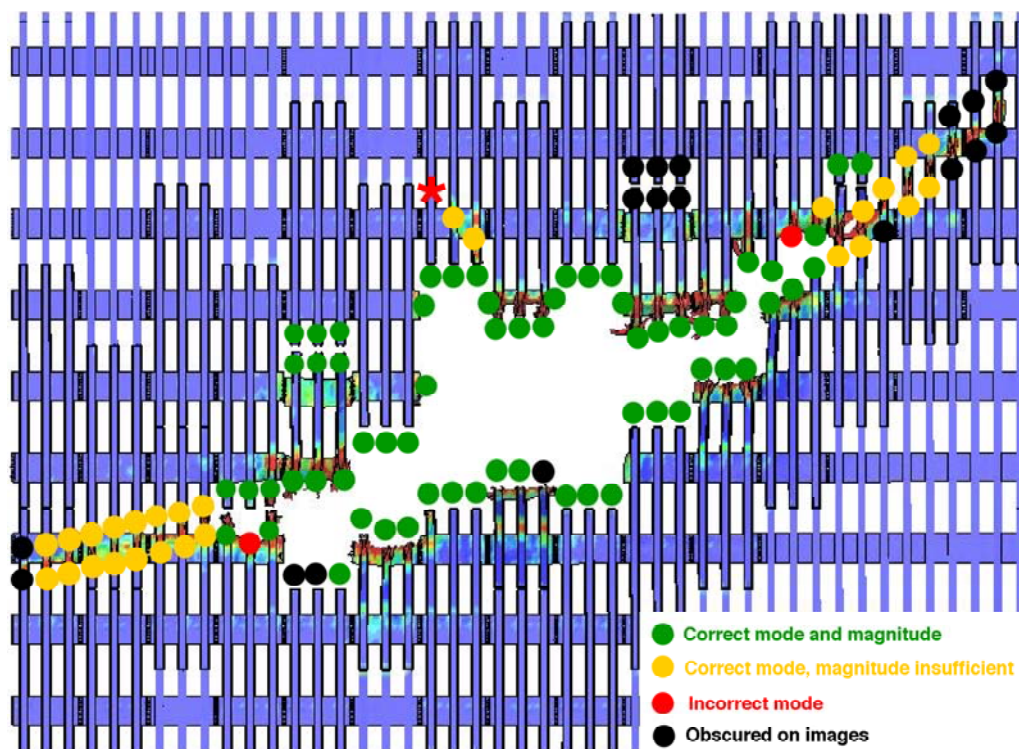
Figure 6-28. Schematic of observed damage (above) and Case C calculated damage (right) to the south face of WTC 2.

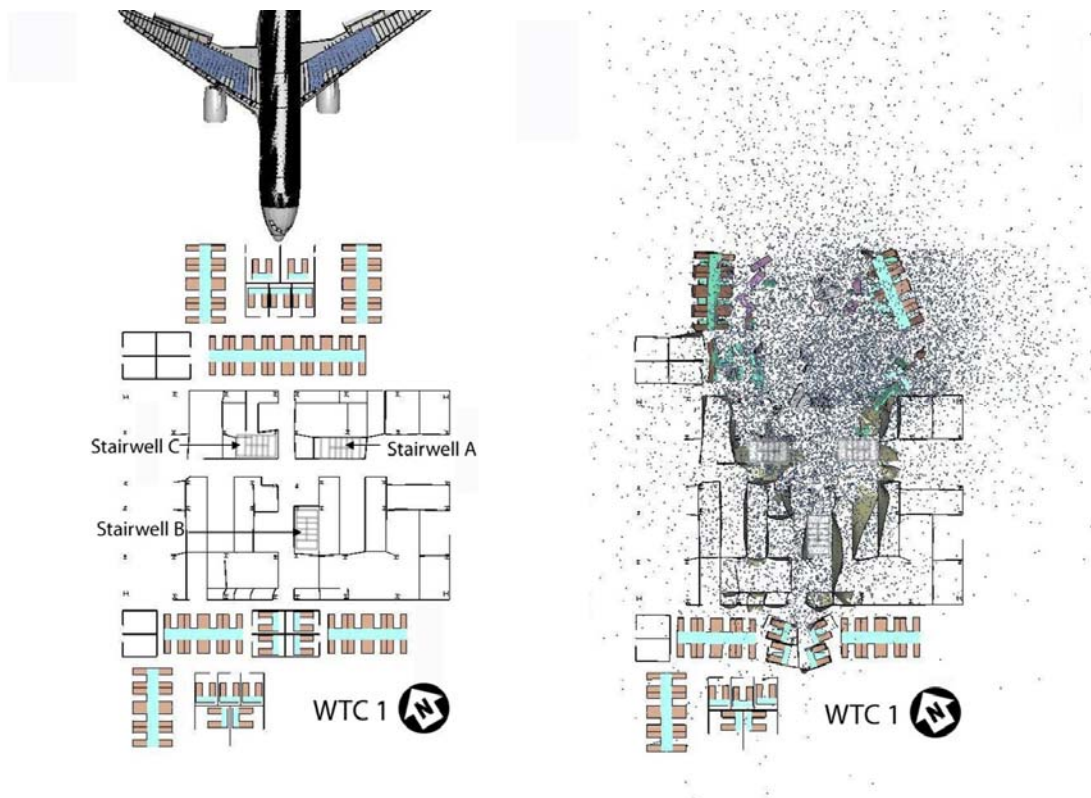
**Figure 7–1. Simulated impact damage to 95<sup>th</sup> floor of WTC 1, including stairwells, 0.7 s after impact.**

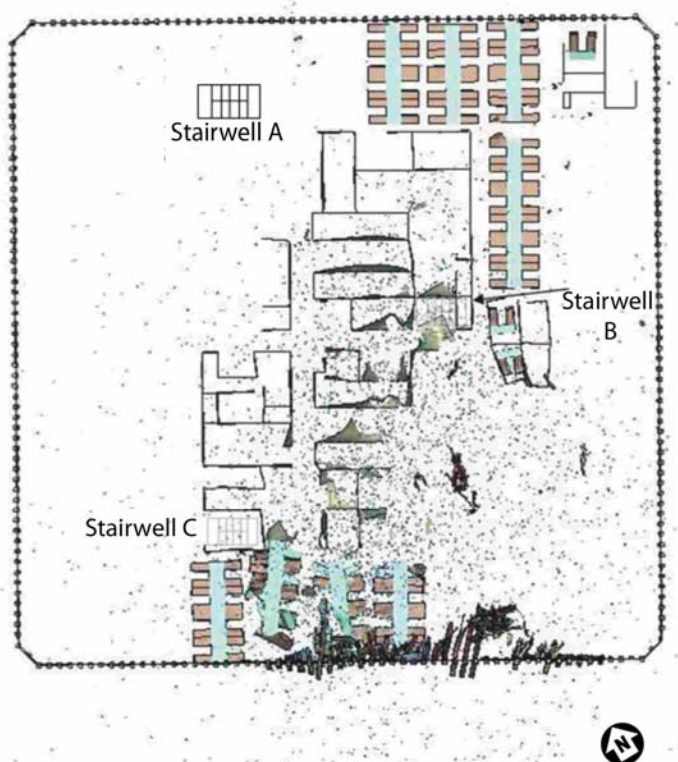
**Figure 7–2. Simulated impact damage to WTC 2 on floor 78, 0.62 s after impact.**

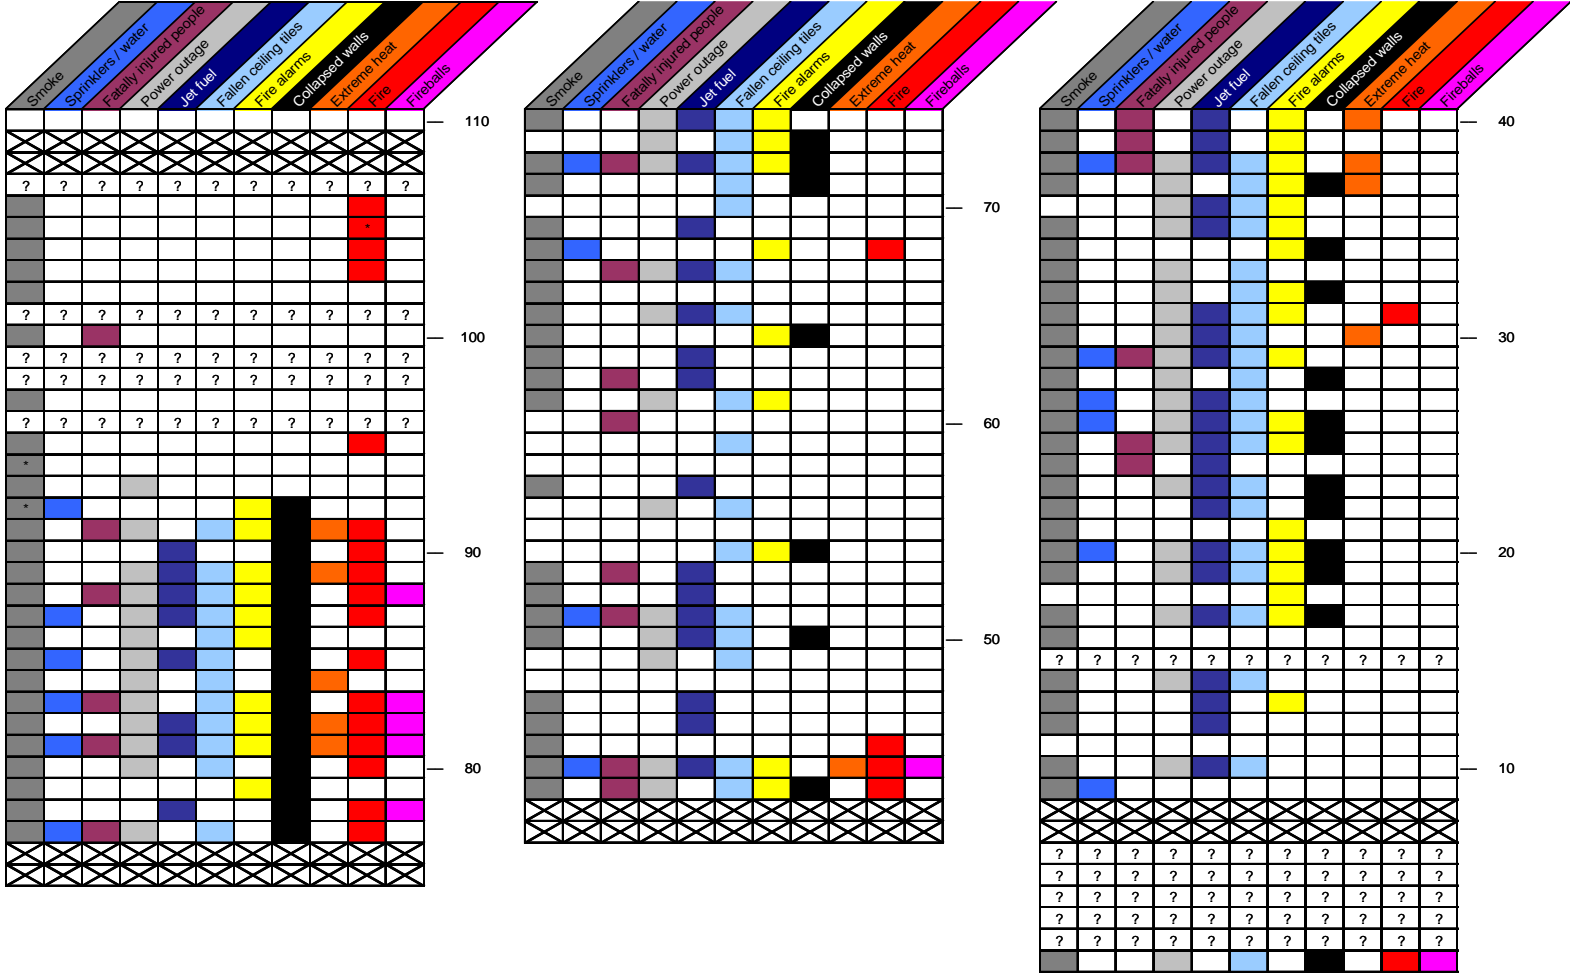
Figure 7–3. Observations of building damage after initial awareness but before beginning evacuation in WTC 1.

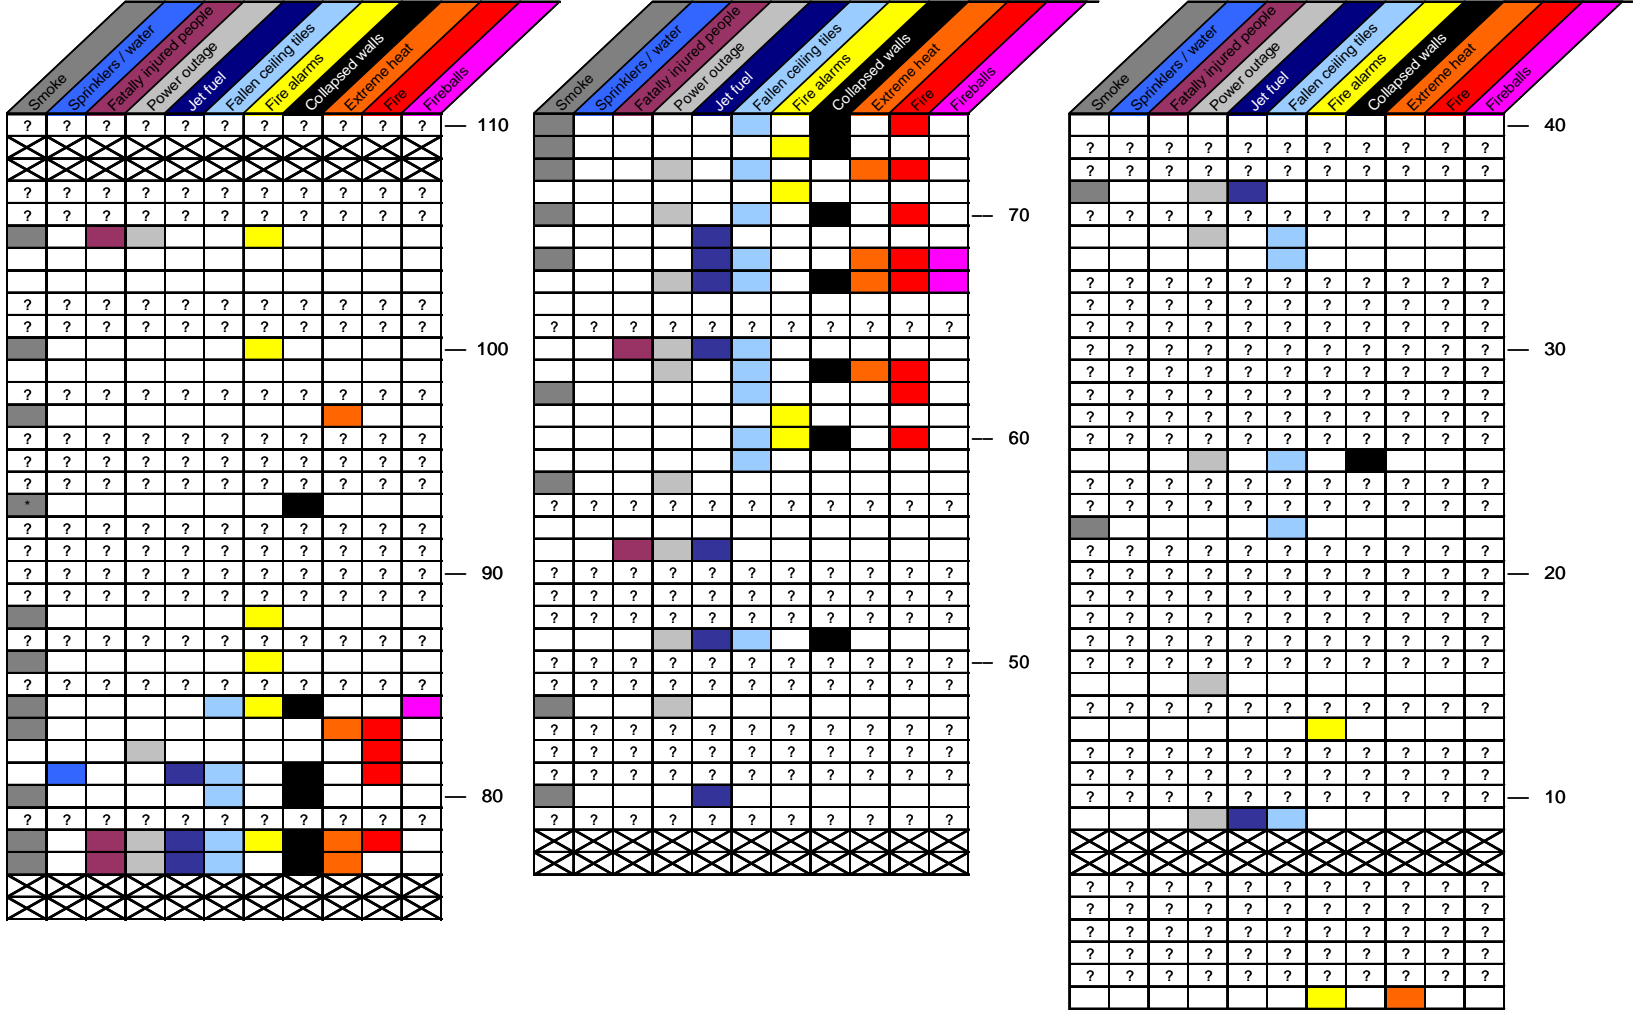
Figure 7–4. Observations of building damage from tenant spaces in WTC 2.
