**NIST NCSTAR 1**

Federal Building and Fire Safety Investigation  
of the World Trade Center Disaster

# **Final Report** on the **Collapse of the World Trade Center Towers**

September 2005

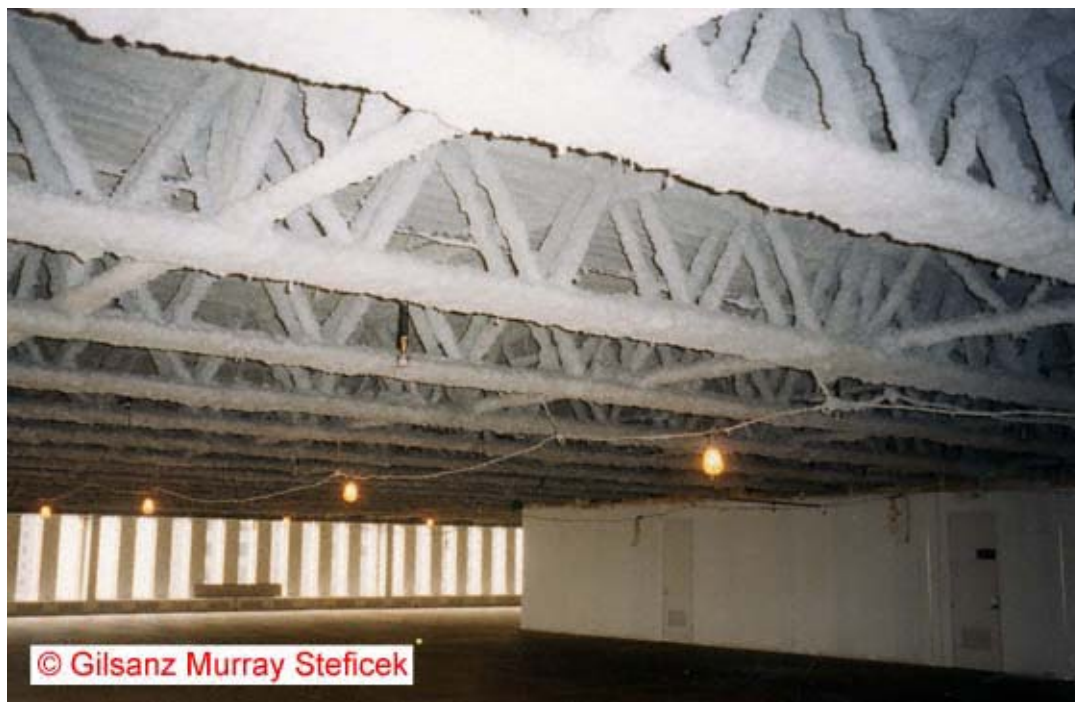
**Figure 1–8. Photograph of insulated WTC trusses.**

three different sprayed fire-resistive material (SFRM). In this report, these materials are collectively referred to as “insulation.”<sup>4</sup> The thickness of the wallboard or the SFRM was selected to provide an intended level of thermal protection. Figure 1–8 shows the appearance of a floor truss with sprayed insulation.

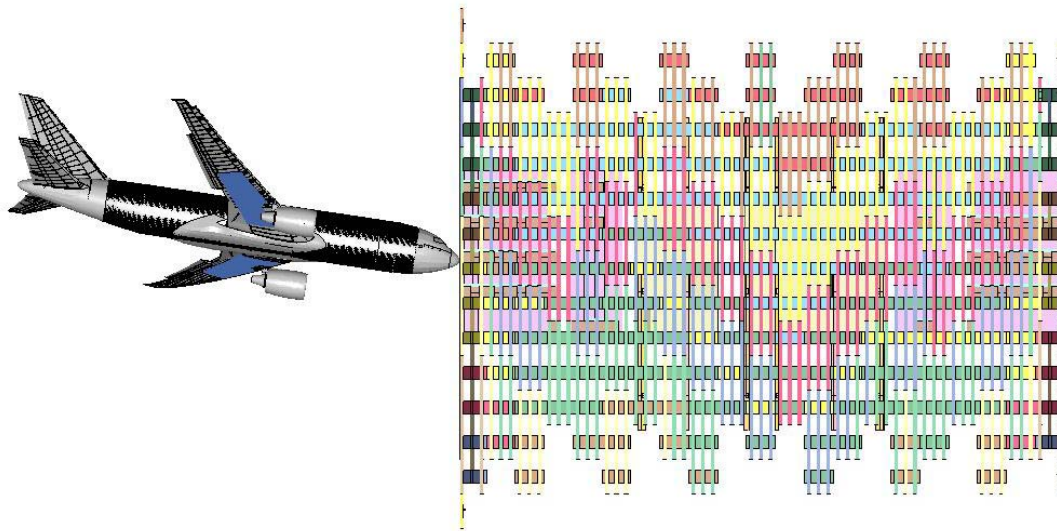
**Figure 2–1. Simulated impact of American Airlines Flight 11 with WTC 1.**

At 8:46:30 a.m. EDT, five hijackers flew American Airlines Flight 11 (AA 11) with 11 crew and 76 passengers into the north face of WTC 1 (Figure 2–1).

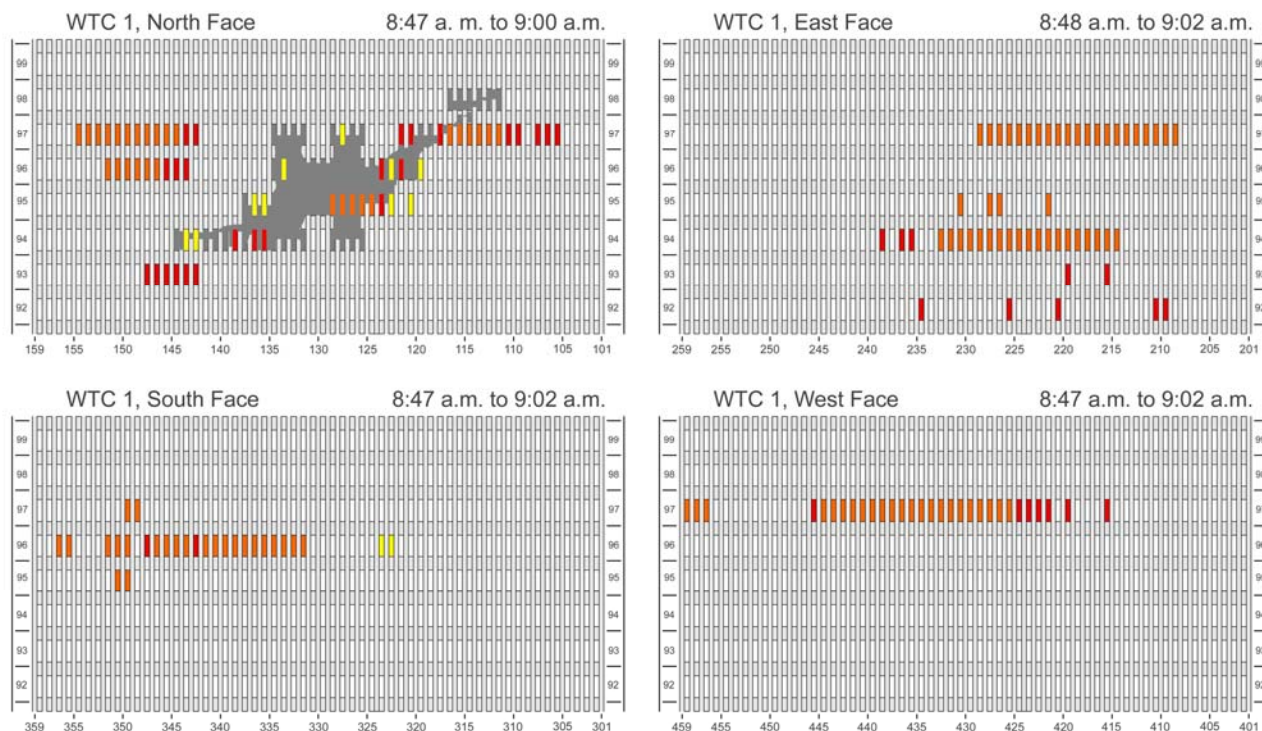
**Figure 2-5. Representation of exterior views of the fires on the four faces of WTC 1 from 8:47 a.m. to about 9:02 a.m.**

There was no way to fight the fires. The piping providing the water supply to the automatic sprinklers had been broken, and water was flowing down the stairwells. Even had this not happened, the system was designed to supply water to about 8 sprinkler heads at one time, enough to control the flames from as much as 1,500 ft<sup>2</sup> of burning material. The water supply was likely sufficient to control fires up to triple that size. The fires, however, had already grown far larger than that.

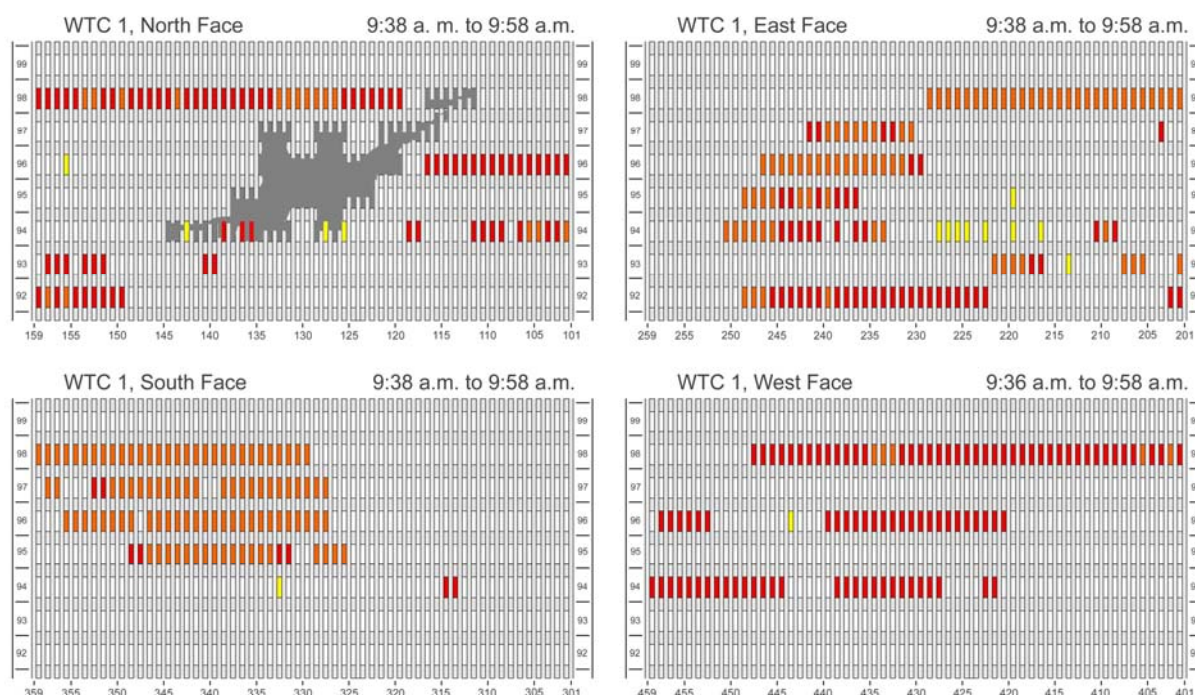
**Figure 2–7. Representation of exterior views of the fires on the four faces of WTC 1 from about 9:38 a.m. to 9:58 a.m.**

Seventy-five minutes after the impact, approaching 10:00 a.m., the fire on the 97<sup>th</sup> floor had begun to burn itself out, but the fire on the 94<sup>th</sup> floor had intensified and filled much of the north half of the floor (Figure 2–7). Starting about 9:30 a.m., there were vigorous fires on nearly the full perimeter of the 98<sup>th</sup> floor. There was still almost no burning on the 99<sup>th</sup> floor or above.

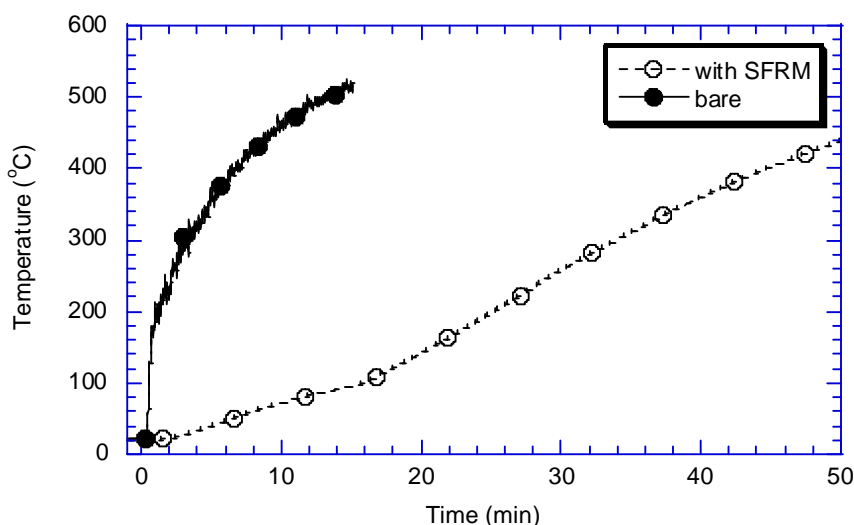
**Figure 2–8. Steel surface temperatures on the bottom chords of fire-exposed trusses, uninsulated and insulated with  $\frac{3}{4}$  in. of BLAZE-SHIELD DC/F.**

The perimeter columns, floors, and core columns were immersed in these hot gases and began to weaken. Where the insulation was dislodged, the temperature of the steel rose rapidly, in contrast to steel members where insulation was intact (Figure 2–8). The heaviest core columns with damaged insulation heated slowly, as the absorbed heat was dissipated through their massive cross sections. The temperatures of the lighter columns and the floor slabs rose more quickly, and those of the stripped trusses even more so.

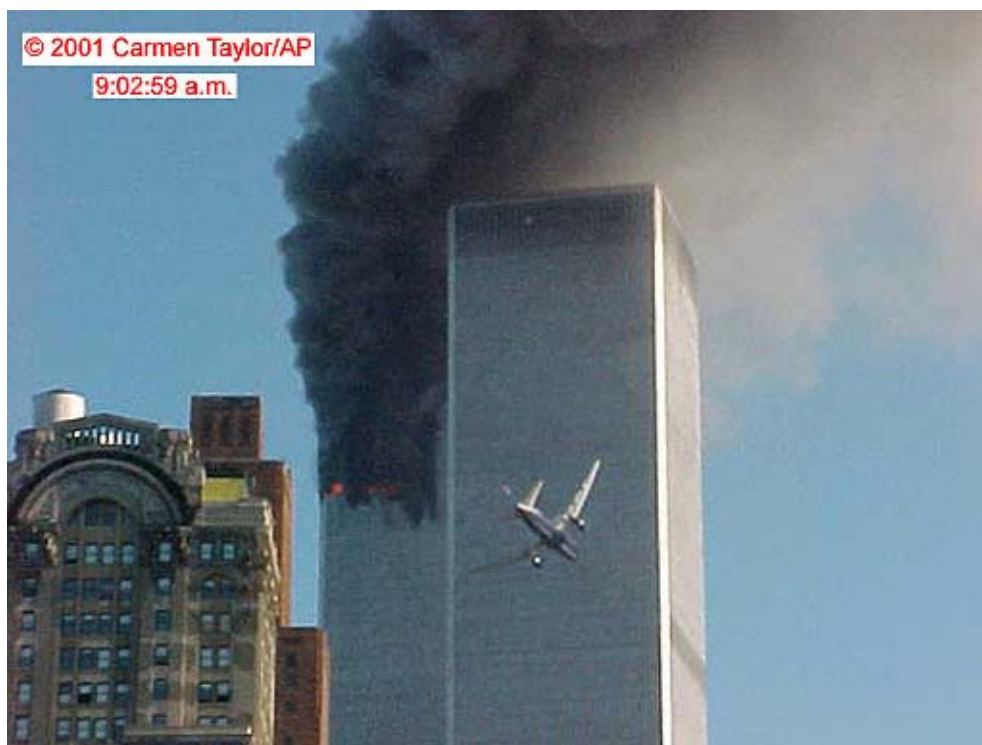
**Figure 3–1. Imminent impact of United Airlines Flight 175 with WTC 2.**

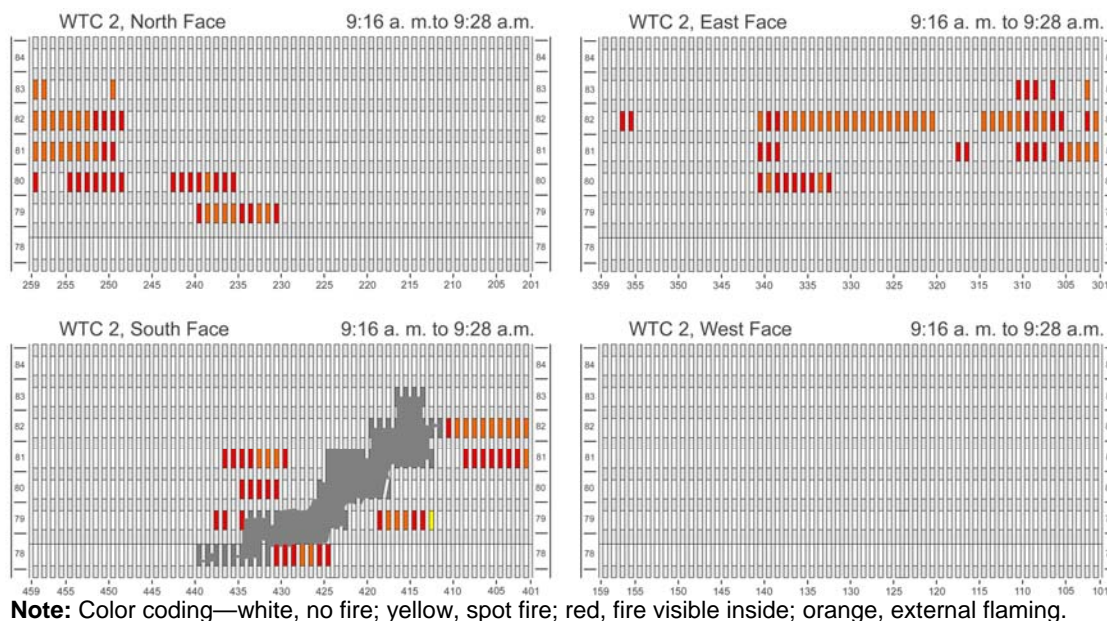
For the next half hour, small fires were burning in and near the aircraft impact cavity on the south side of the building. There were vigorous fires on the east side of the 80<sup>th</sup> through 83<sup>rd</sup> floors (Figure 3–4), especially on the northeast end of the 81<sup>st</sup> and 82<sup>nd</sup> floors, where the aircraft had bulldozed the office desks and chairs and added its own combustibles. In addition to the ample supply of fuel, these fires had access to plenty of air, as numerous windows on the east face had been blown out by the impact or fireball. They would continue to burn as long as the building stood.

**Figure 3–4. Representation of exterior views of the fires on the four faces of WTC 2 at about 9:20 a.m.**

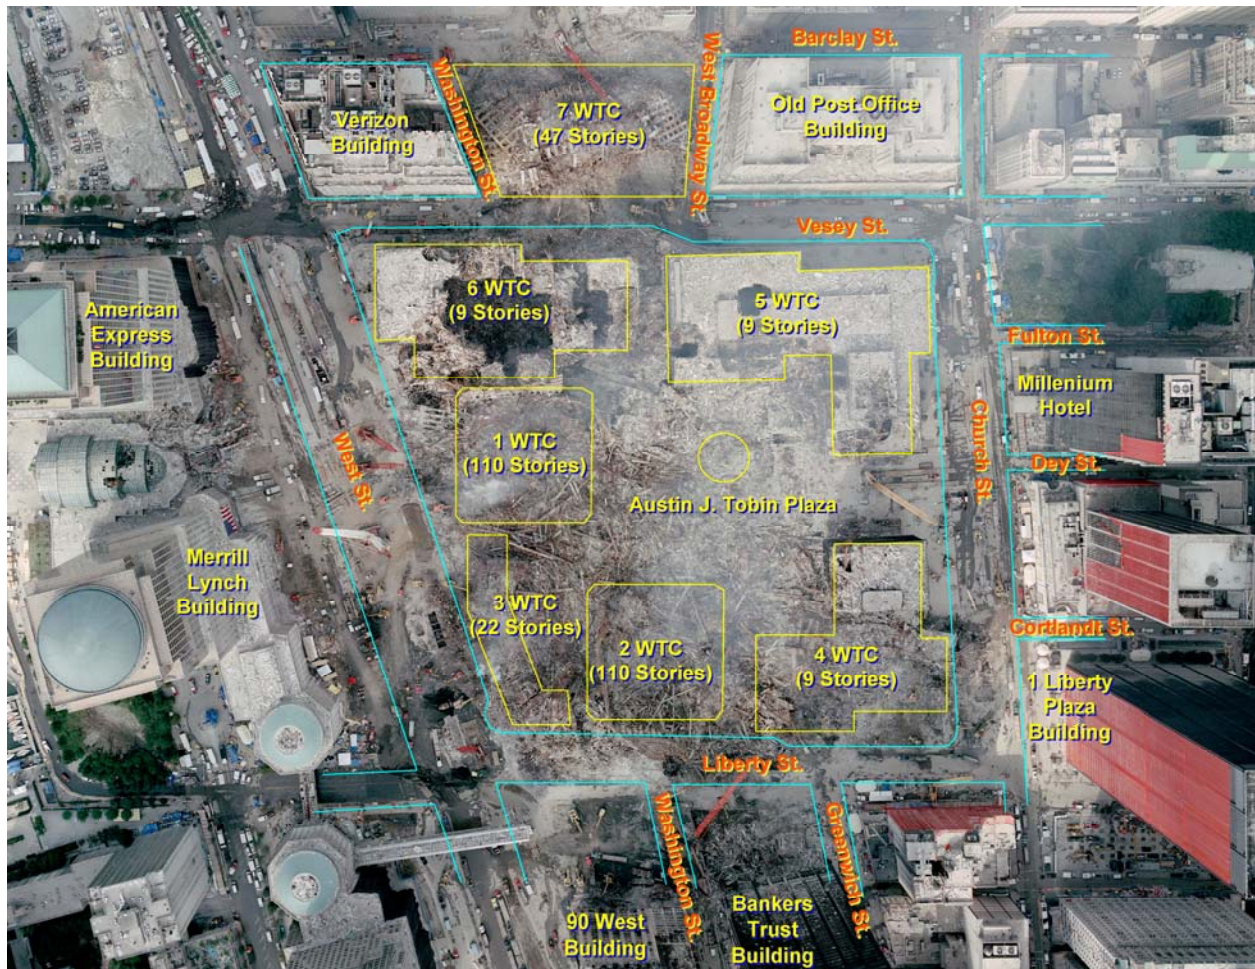
By sunset on September 11, 2001, all seven buildings on the World Trade Center (WTC) site lay in ruins (Figure 4–1). Table 4–1 compiles the likely locations of the decedents.

Figure 4–1. The WTC site on September 17, 2001.

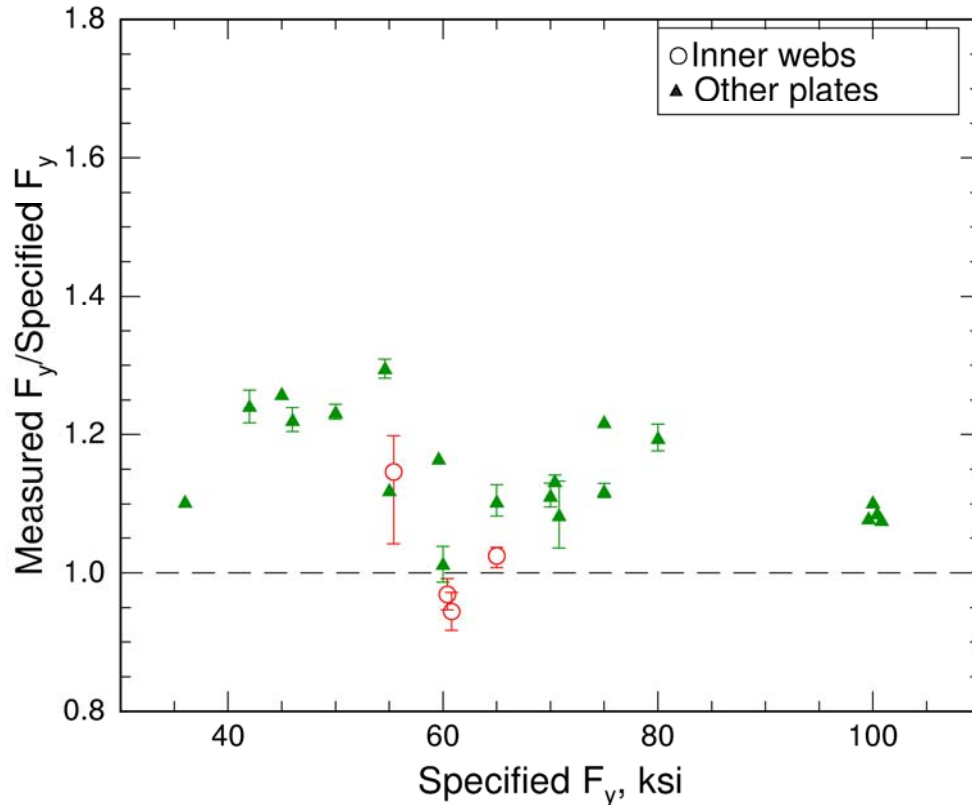
- The yield strengths of many of the steels in the floor trusses were above 50 ksi, even when they were specified to be 36 ksi.
- Tests on a limited number of recovered bolts showed they were much stronger than expected based on reports from the contemporaneous literature.

**Note:** The ratio values less than 1 arose from natural variation in the steel and did not affect the safety of the towers on September 11, 2001. The bars represent maximum and minimum values from multiple measurements.

**Figure 5-4. Ratio of measured yield strength ( $F_y$ ) to specified minimum yield strength for steels used in WTC perimeter columns.**

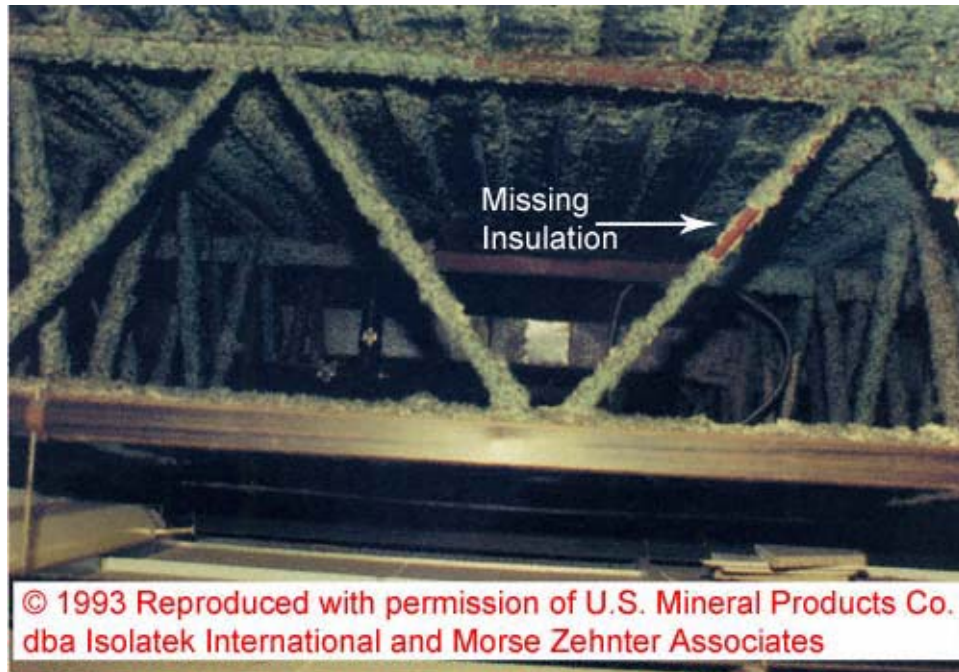
In 1994, The Port Authority measured the SFRM thickness on trusses on floors 23 and 24 of WTC 1. In all, average thicknesses were reported for 32 locations, and the overall average thickness was found to be 0.74 in. NIST performed a further evaluation of the SFRM thickness using photographs taken in the 1990s of floor trusses on (non-upgraded) floors 22, 23, and 27 of WTC 1 (Figure 5–5). By measuring dimensions on the photographs, NIST estimated the insulation thicknesses on the diagonal web members of trusses. (The thickness of chord member insulation could not be measured.) The average thickness and standard deviation of web members was 0.6 in. ± 0.3 in. on the main trusses, 0.4 in. ± 0.25 in. on the bridging trusses, and 0.4 in. ± 0.2 in. on the diagonal struts. These numbers indicated that there were areas where the coating thickness was less than the specified 0.5 in.

**Figure 5–5. Irregularity of coating thickness and gaps in coverage on SFRM-coated bridging trusses.**

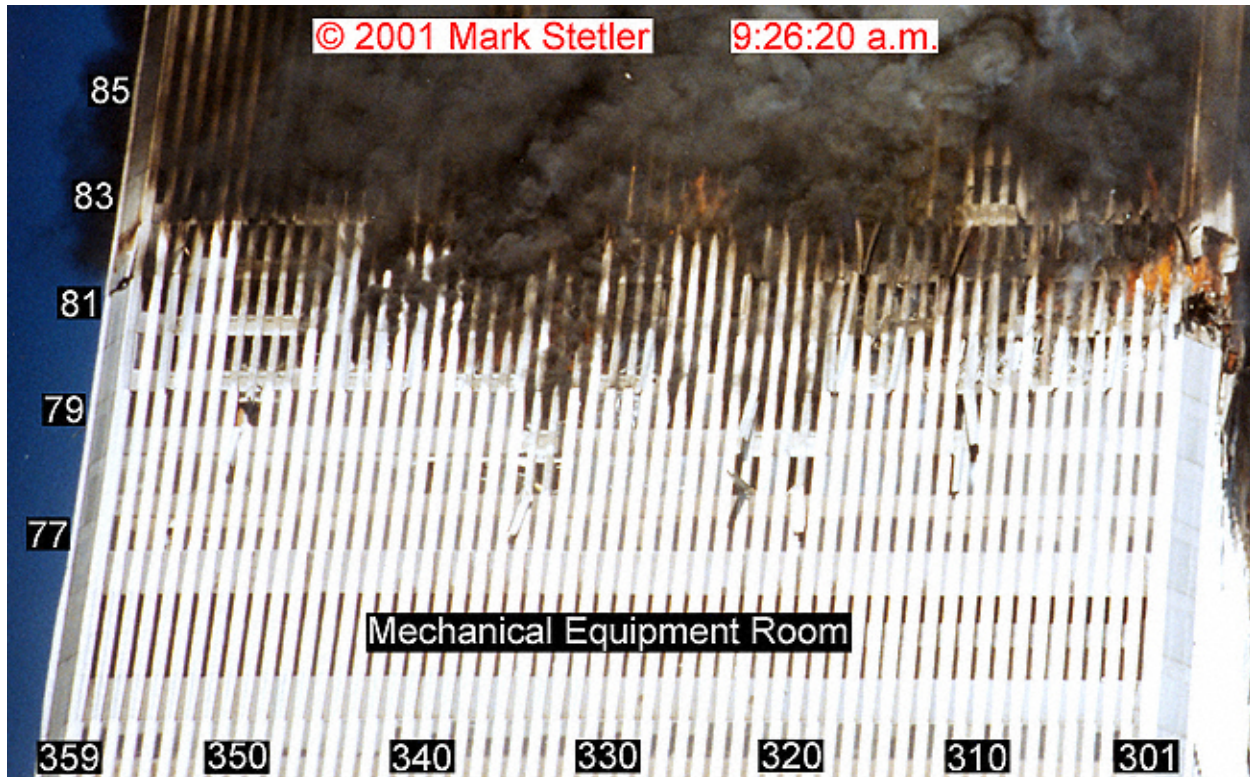
As an example of information that was extracted, Figure 6–1 shows an enhanced image of the east face of WTC 2. Figure 6–2 expands a section of interest. The amount of detail available is evident. For instance, large piles of debris are present on the north side of the tower on the 80<sup>th</sup> and 81<sup>st</sup> floors, and locations where fires are visible or where missing windows are easily identified. Many details of each frame were important in tracking the evolution of the fires and the damage to the buildings.

**Figure 6–1. 9:26:20 a.m. showing the east face of WTC 2.**

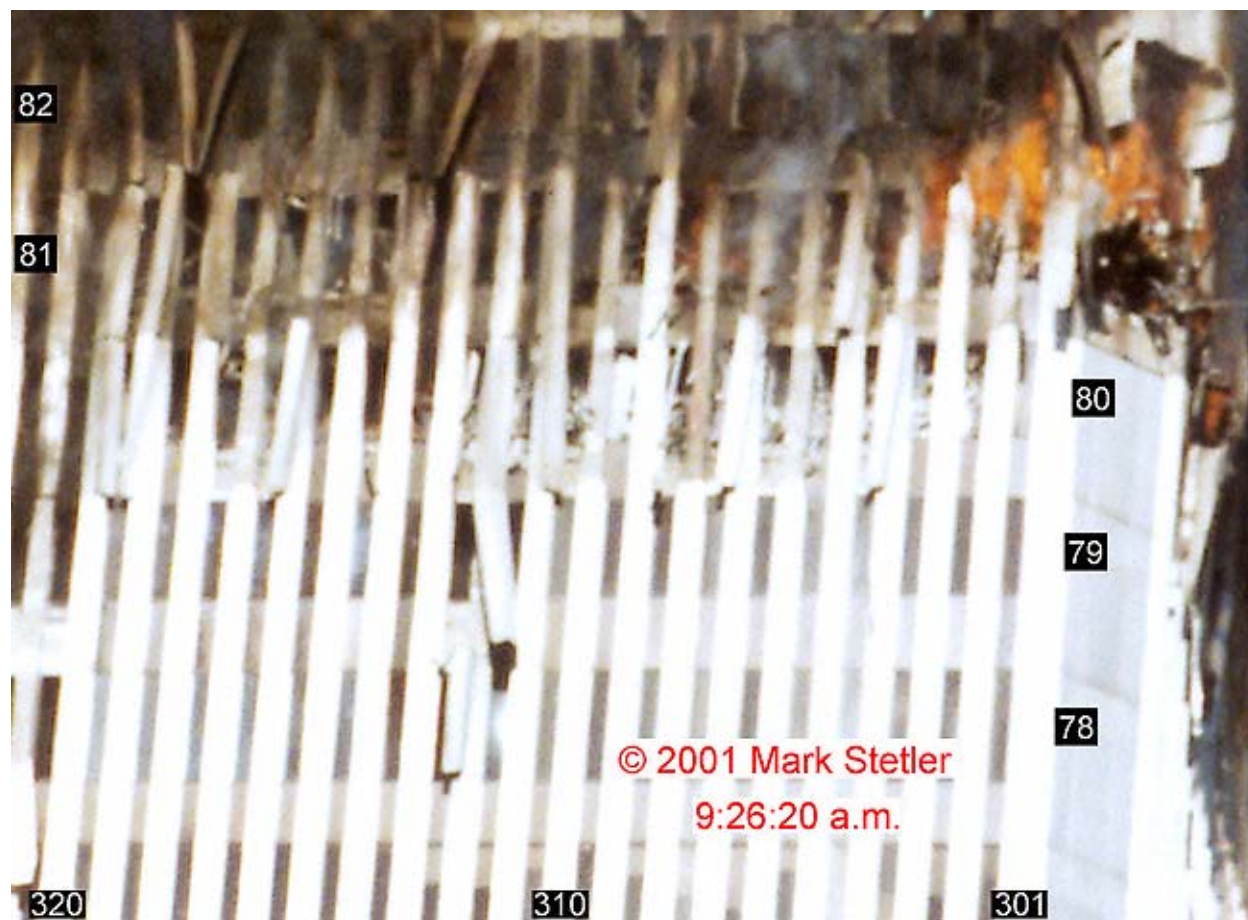
**Figure 6–2. Close-up of section of Figure 6–1.**

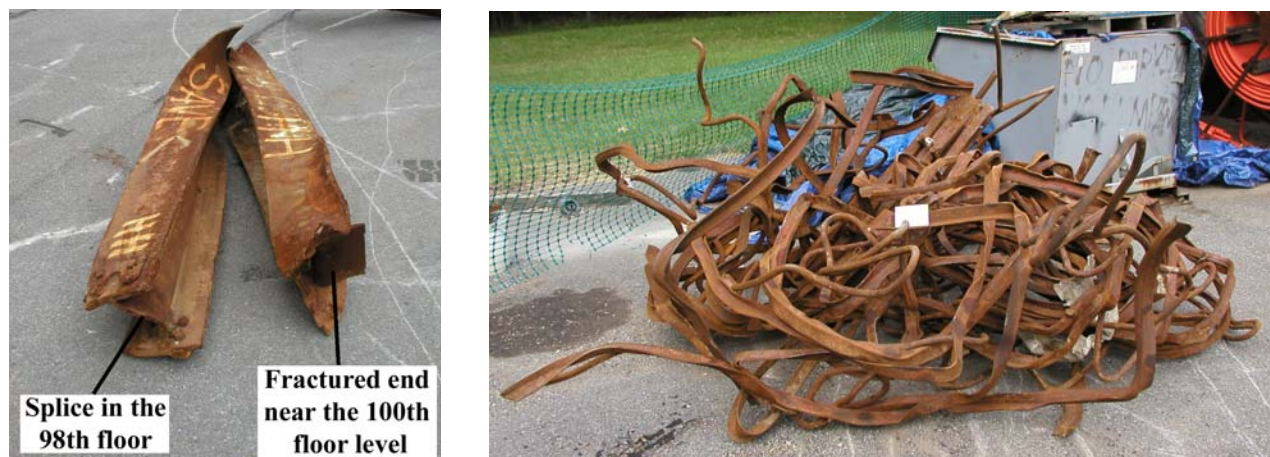
**Figure 6–3. Examples of a WTC 1 core column (left) and truss material (right).**

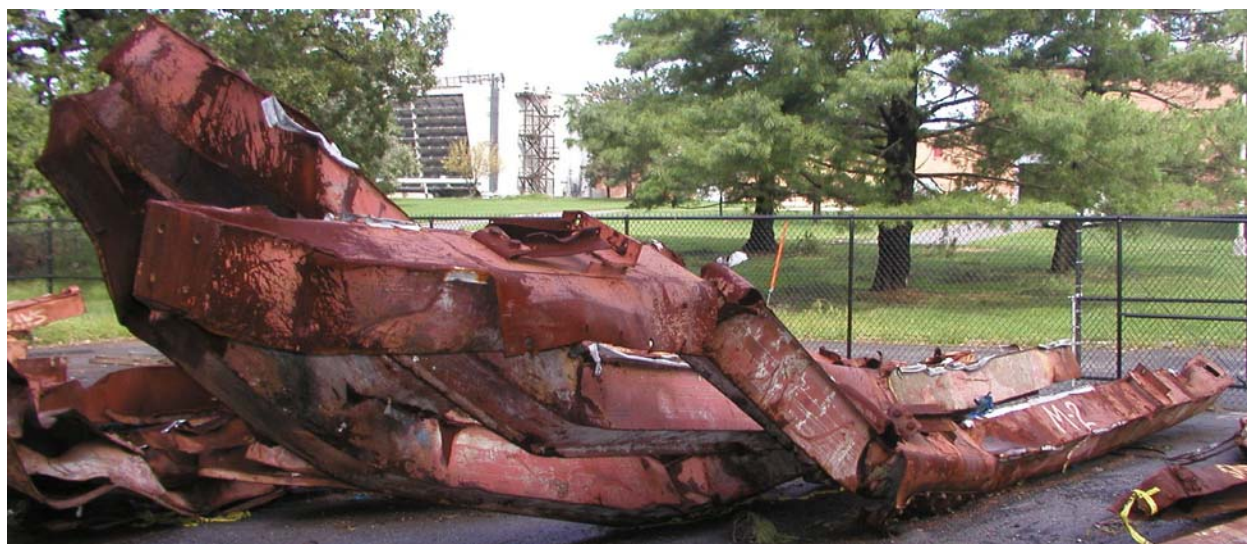
**Figure 6–4. WTC 1 exterior panel hit by the fuselage of the aircraft.**

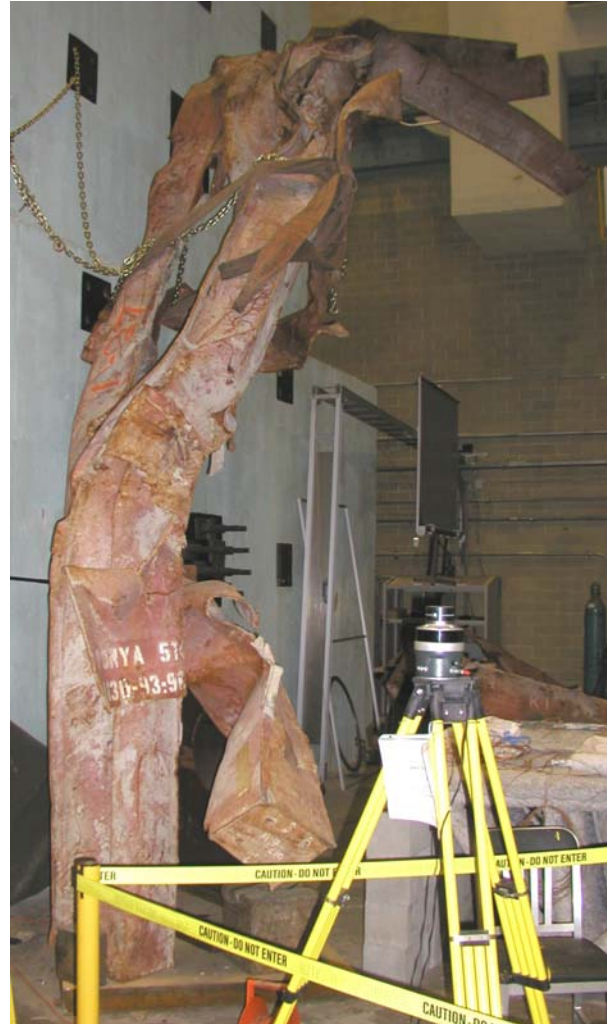
**Figure 6–5. WTC 1 exterior panel hit by the nose of the aircraft.**

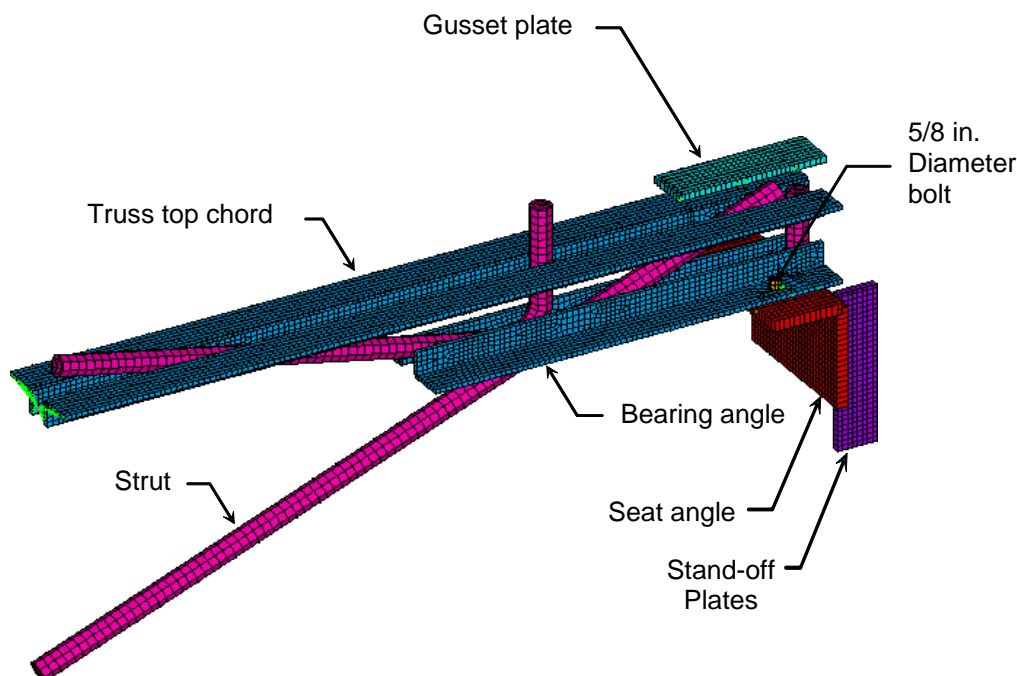
**Figure 6-10. Finite element model of an exterior truss seat.**

- **Truss seats.** Figure 6–10 shows how an exterior seat connection was represented in the finite element structural model. The component analysis determined that failure could occur at the bolted connection between the bearing angle and the seat angle, and the truss could slip off the seat. Truss seat connection failure from vertical loads was found to be unlikely, since the needed increase in vertical load was unreasonable for temperatures near 600 °C to 700 °C.
- **Knuckles.** The “knuckle” was formed by the extension of the truss diagonals into the concrete slab and provided for composite action of the steel truss and concrete slab. A model was developed to predict the knuckle performance when the truss and concrete slab acted compositely.

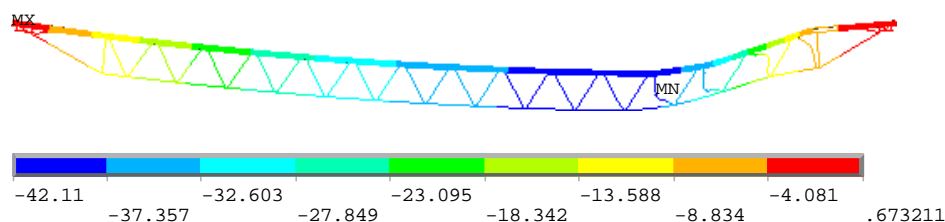
**Figure 6-11. Vertical displacement at 700 °C.**

- Single composite truss and concrete slab section. A floor section was modeled to investigate failure modes and sequences of failures under combined gravity and thermal loads. The floor section was heated to 700 °C (with a linear thermal gradient through the slab thickness from 700 °C to 300 °C at the top surface of the slab) over a period of 30 min. Initially the thermal expansion of the floor pushed the columns outward, but with increased temperatures, the floor sagged and the columns were pulled inward. Knuckle failure was found to occur mainly at the ends of the trusses and had little effect on the deflection of the floor system. Figure 6-11 shows that the diagonals at the core (right) end of the truss buckled and caused an increase in the floor system deflection, ultimately reaching approximately 42 in. Two possible failure modes were identified for the floor-truss section: sagging of the floor and loss of truss seat support.

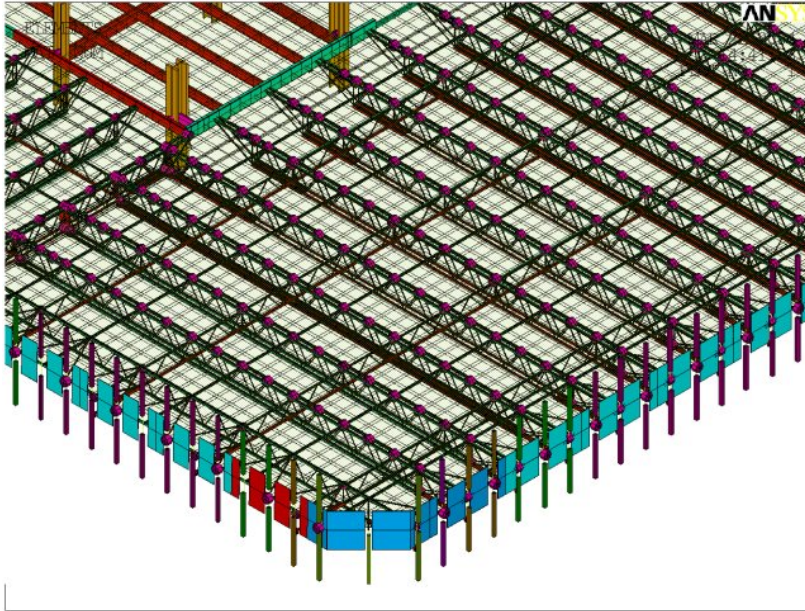
**Figure 6–12. ANSYS model of 96<sup>th</sup> floor of WTC 1.**

The model was used to evaluate structural response under dead and live loads and elevated temperatures, identify failure modes and associated temperatures and times to failure, and identify reductions in modeling complexity for global models and analyses. The structural response included thermal expansion of steel and concrete members, temperature-dependent properties of steel and concrete that affected material stiffness and strength, and bowing or buckling of structural members. The deformation and failure modes identified were floor sagging between truss supports, floor sagging resulting from failure of a seat at either end of the truss, and failure of the floor subsystem truss supports.

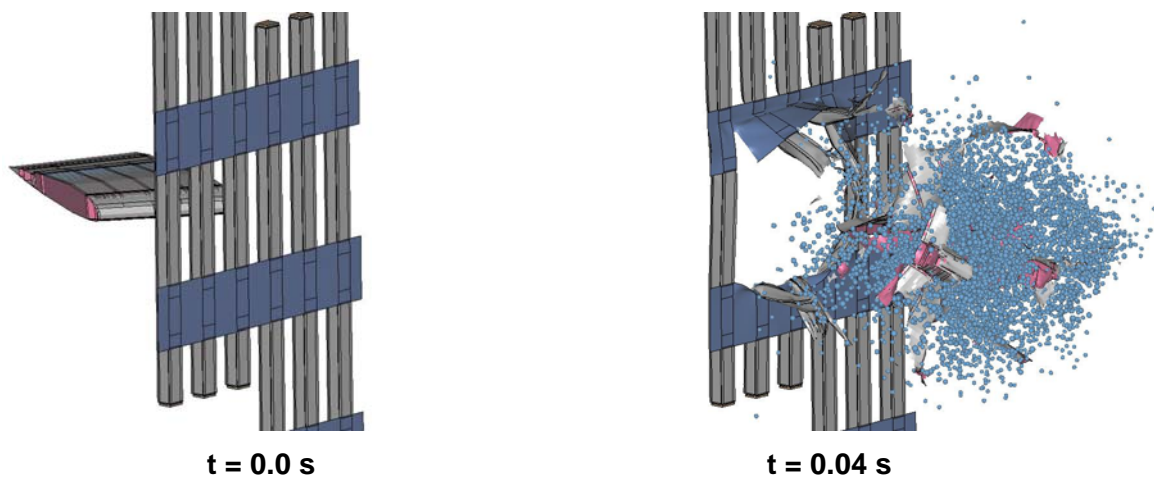
**Figure 6–16. Calculated impact on an exterior wall by a fuel-laden wing section.**

Figure 6–16 shows two frames from the last of these analyses, with the wing segment entering from the left, being fragmented as it penetrates the exterior columns, and spraying jet fuel downstream.

- Moving at 500 mph, an engine broke any exterior column it hit. If the engine missed the floor slab, the majority of the engine core remained intact and had enough residual momentum to sever a core column upon direct impact.
- The impact of the inner half of an empty wing significantly damaged exterior columns but did not result in their complete failure. Impact of the same wing section, but filled with fuel, did result in failure of the exterior columns.

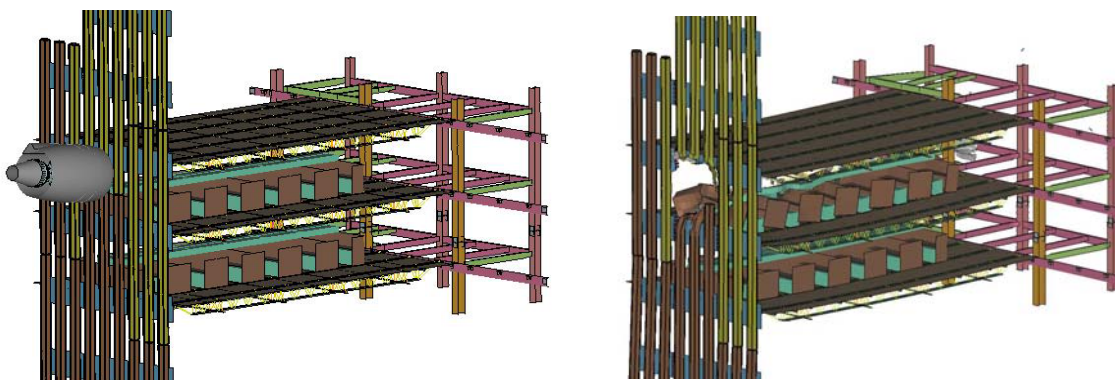
**Figure 6–17. Response of a tower subassembly model to engine impact.**

- The mass of the concrete floor slab and nonstructural contents had a greater effect on the engine deceleration and subsequent damage than did the concrete strength.
- Variation of the failure criteria of the welds in the exterior columns did not result in any noticeable difference in the damage pattern or the energy absorbed by the exterior panels.

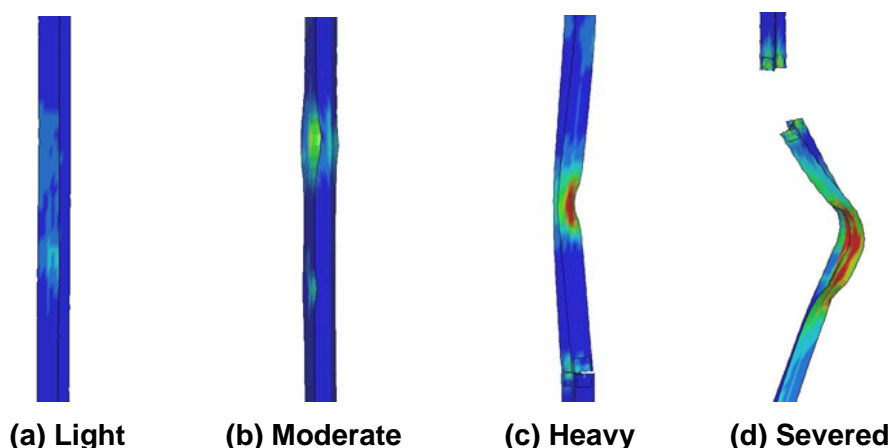
**Figure 6–19. Column damage levels.**

Each of the four global simulations generated information about the state of the structural components following the impact of the aircraft. The four degrees of column damage are defined as follows and shown graphically in Figure 6–19. The unstrained areas are blue and the highly strained areas are red.

- Lightly damaged column: column impacted, but without significant structural deformation;
- Moderately damaged column: visible local distortion, but no deformation of the column centerline;
- Heavily damaged column: Permanent deflection of the column centerline; and
- Failed column: Column severed.

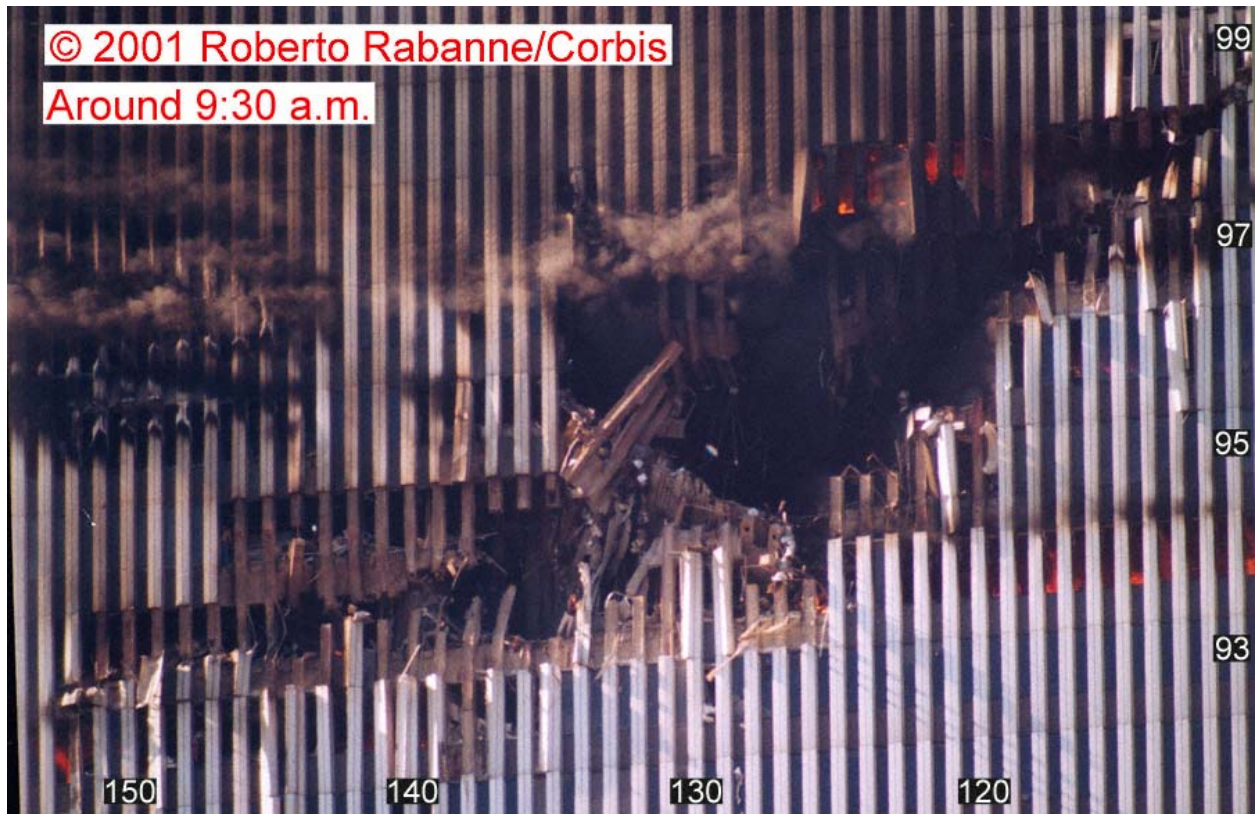
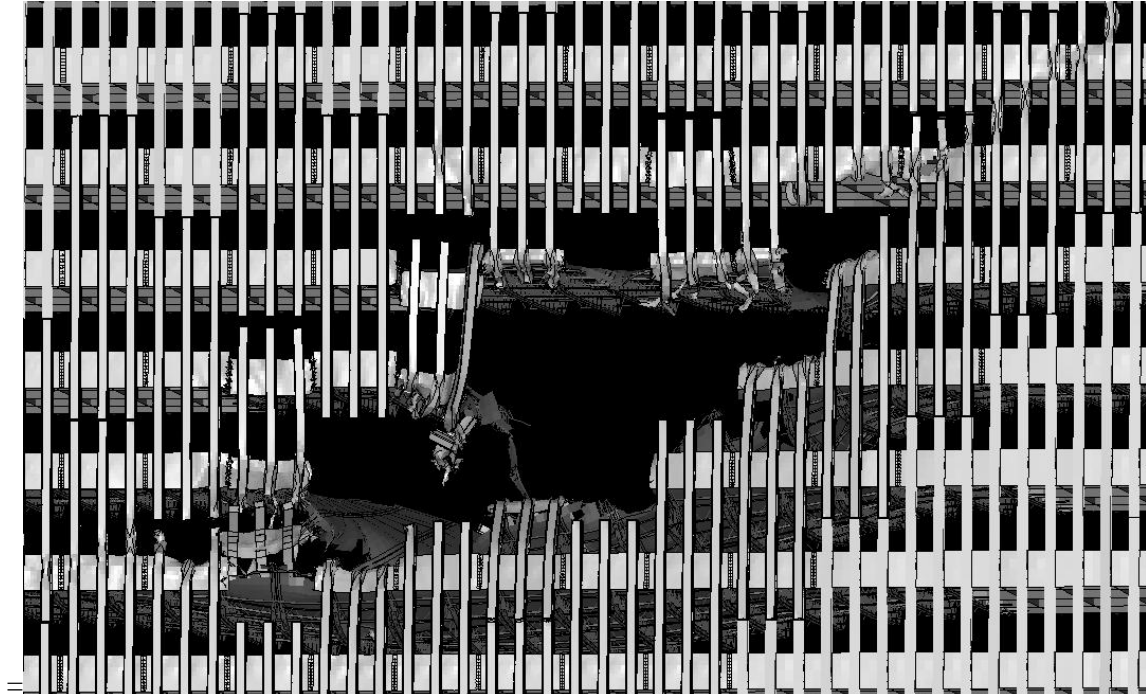
Figure 6–26. Observed and Case A calculated damage to the north face of WTC 1.

Assessment of the aircraft impact simulations of exterior damage to the towers involved comparing the predicted perimeter wall damage near the impact zone with post-impact photographs of the walls.

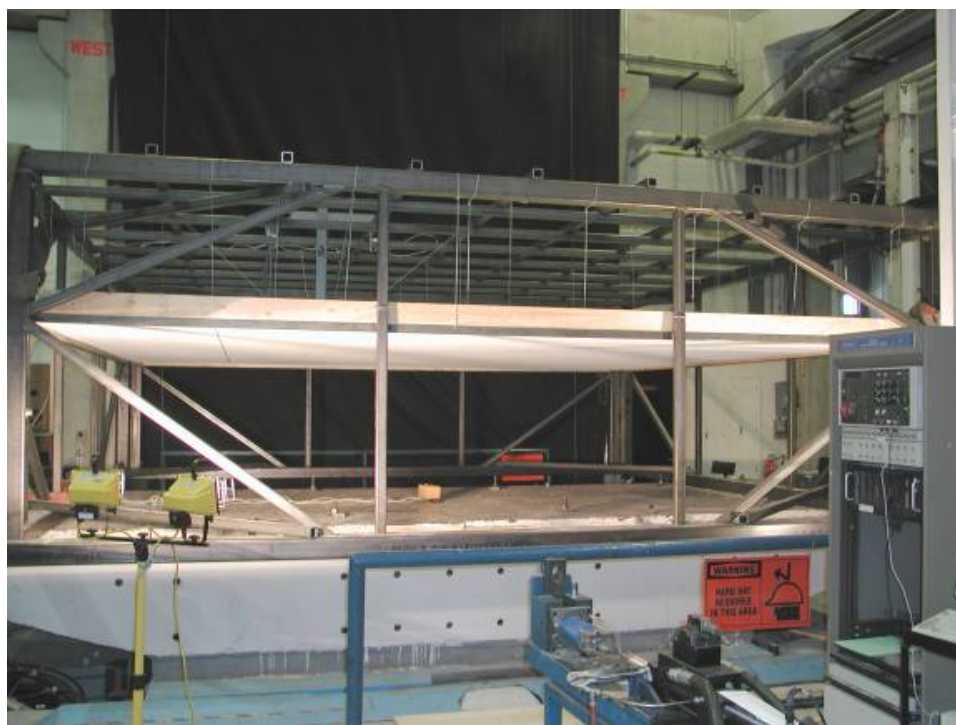
**Figure 6–29. Ceiling tile system mounted on the shaking table.**

The aircraft impact modeling did not include the ceiling tile systems. To estimate whether the tiles would survive the aircraft impact, the University at Buffalo, under contract to NIST, conducted tests of WTC-like ceiling tile systems using their shake table (Figure 6–29) and impulses related to those induced by the aircraft impact on the towers. The data indicated that accelerations of approximately 5g would most likely result in substantial displacement of ceiling tiles. Given the estimated impact accelerations of approximately 100g, NIST assumed that the ceiling tiles in the impact and fire zones were fully dislodged. This was consistent with the multiple reports of severely damaged ceilings (Chapter 7).

An intact ceiling tile system could have provided the floor trusses with approximately 10 min to 15 min of thermal protection from ceiling air temperatures near 1,000 °C. These temperatures would quickly heat steel without thermal insulation to temperatures for reduction of the strength of structural steels.

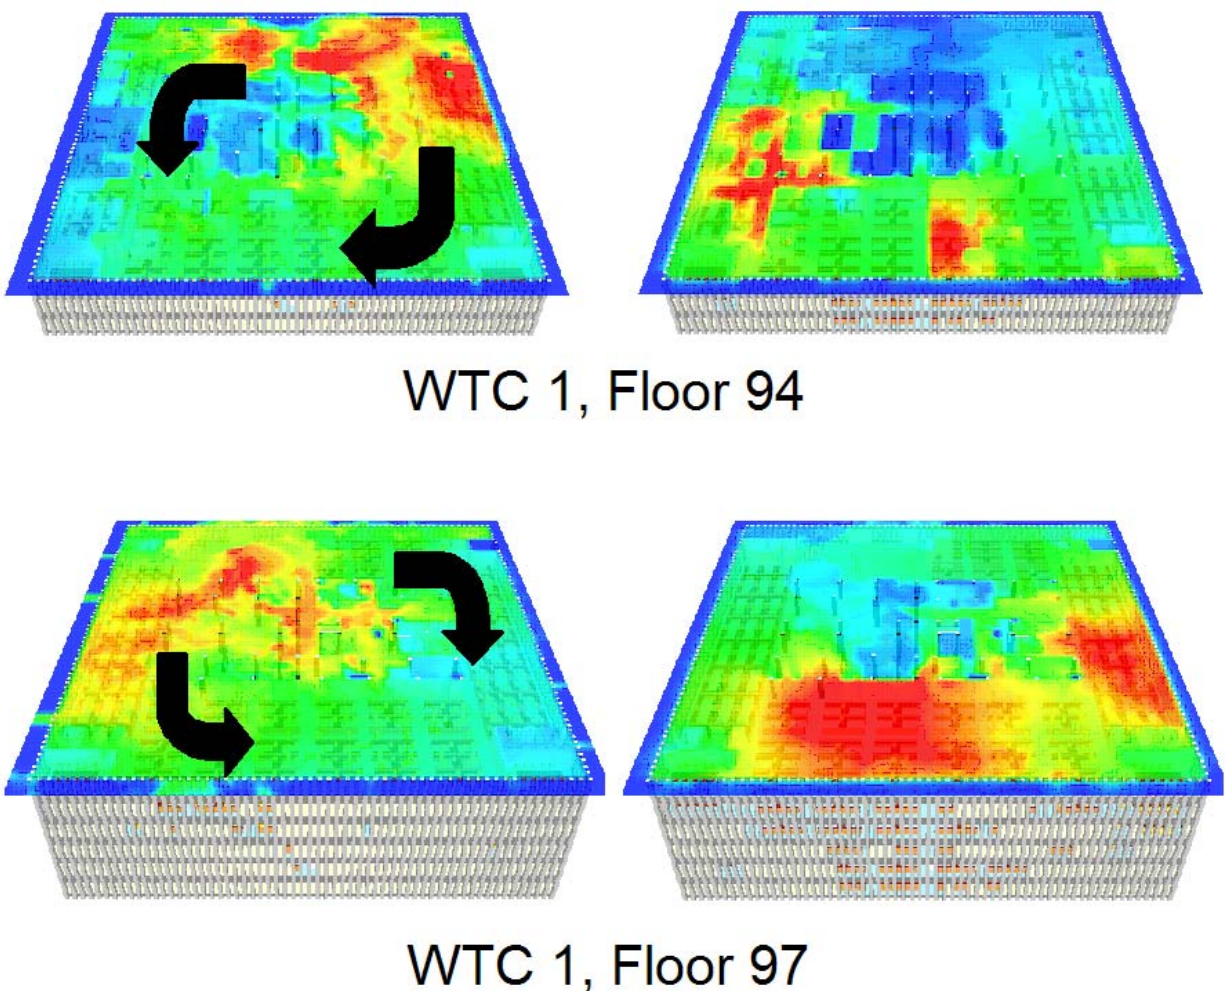
Much of the fire activity was initially in the vicinity of the impact area in the north part of the building. As a result of the orientation of the impacting aircraft and its fuel tanks, the early fires on the 92<sup>nd</sup> through 94<sup>th</sup> floors tended toward the east side of the north face, while the early fires on the 97<sup>th</sup> through 99<sup>th</sup> floors tended toward the west side of the north face. The fires on all the floors spread along the east and west sides and were concentrated in the south part of the building at the time of collapse, as depicted in Figure 6–37.

Figure 6–37. Direction of simulated fire movement on floors 94 and 97 of WTC 1.

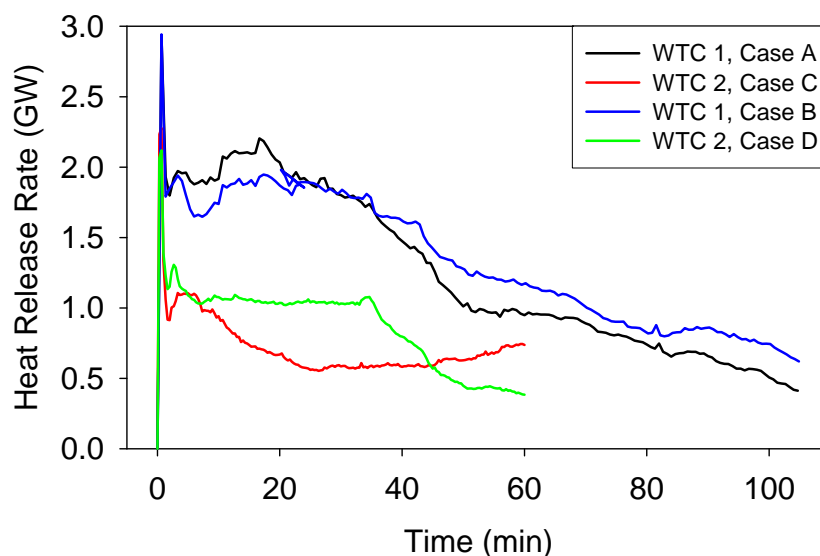
Much of the information needed to simulate the fires came from laboratory-scale tests. While some of these involved enclosures several meters in dimension and fires that reached heat release rates of 10 MW and 12 GJ in total heat output, they were still far smaller than the fires that burned in the WTC towers. Figure 6–38 shows the heat release rates from the FDS simulations of the WTC fires. The peak plateau heat release rates were about 2 GW for WTC 1 and 1 GW for WTC 2. Integrating the areas under these curves produced total heat outputs from the simulated fires of about 8,000 GJ from WTC 1 and 3,000 GJ from WTC 2.

**Figure 6–38. Predicted heat release rates for fires in WTC 1 and WTC 2.**

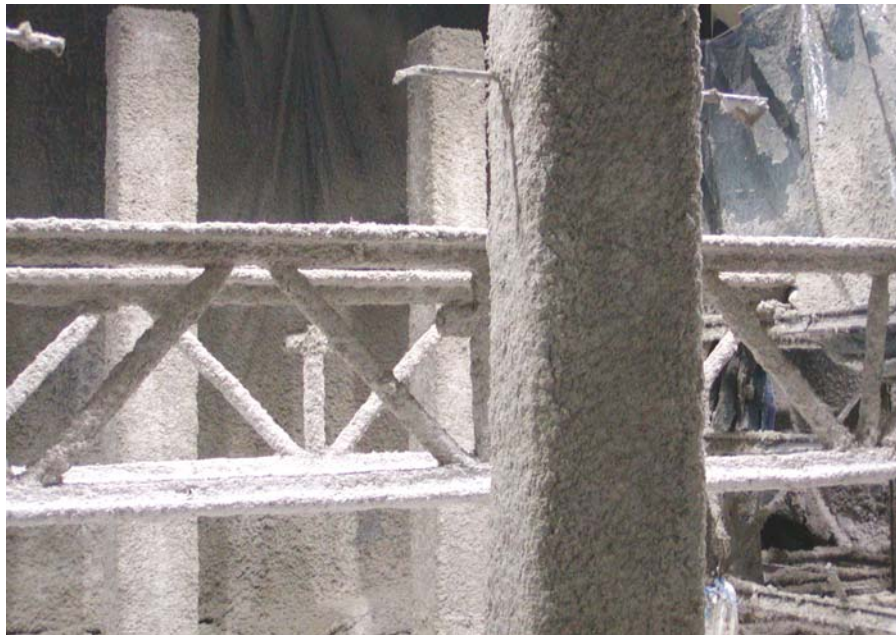
experienced applicator, who took considerable care to apply an even coating of the specified thickness. As such, the insulated test subjects represent a best case in terms of thickness and uniformity. Figure 6–42 shows some of the coated components.

**Figure 6–42. SFRM-coated steel components prior to a test.**
