**NIST NCSTAR 1**

Federal Building and Fire Safety Investigation  
of the World Trade Center Disaster

# **Final Report** on the **Collapse of the World Trade Center Towers**

September 2005

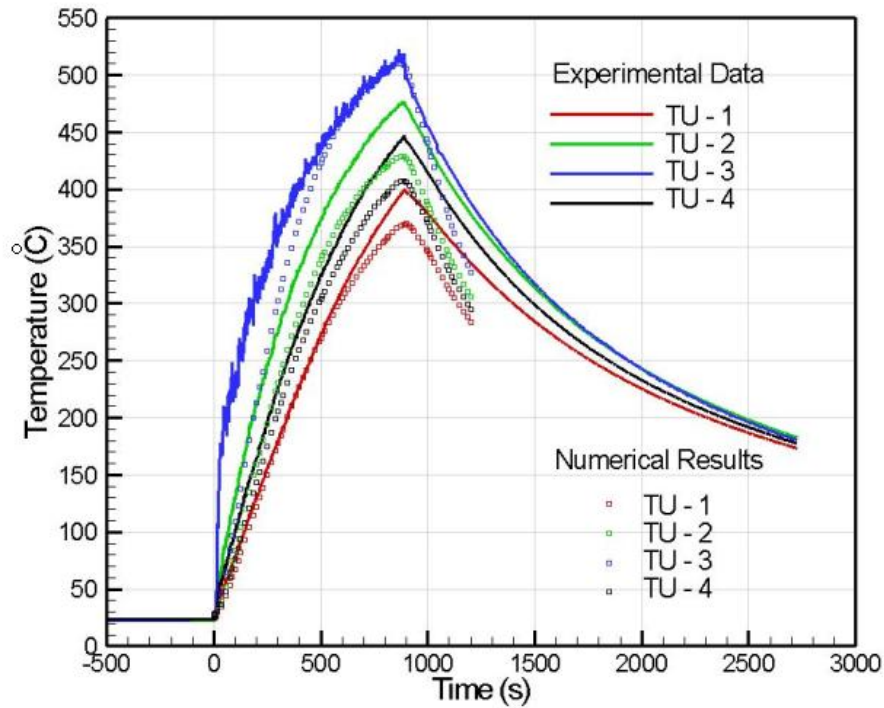
Figure 6–44 compares the measured and predicted temperatures on the steel surface of the top chord of a bare truss. Figure 6–45 is the analogous plot of the measured and predicted temperatures on the steel surface of the top chord of a truss insulated with 3/4 in. of BLAZE-SHIELD DC/F. Similar curves were generated for each of the steel pieces, bare and insulated.

Figure 6-44. Comparison of numerical simulations with measurements for the steel surface temperature at four locations on the top chord of a bare truss.

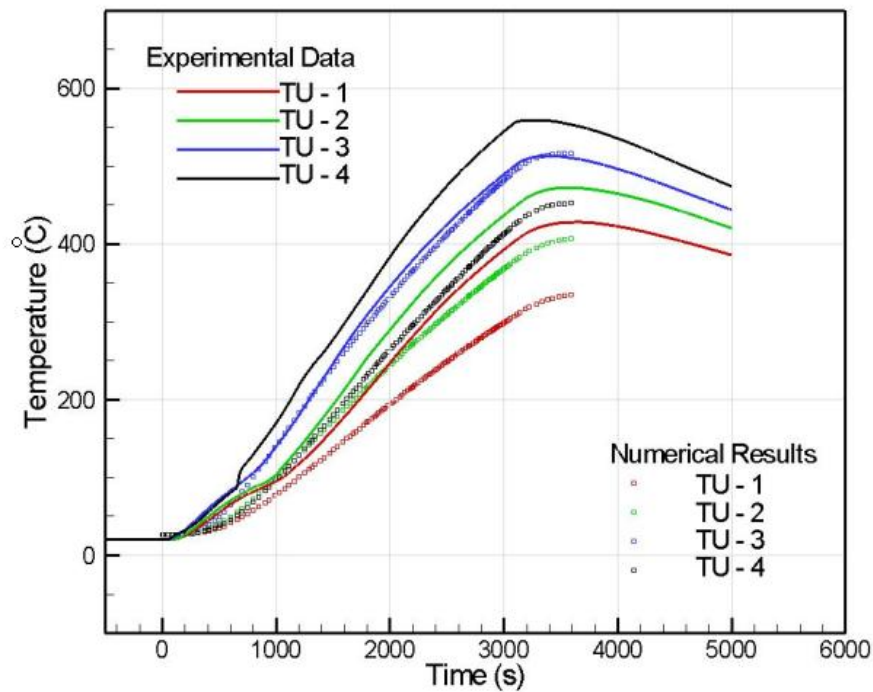
Figure 6-45. Comparison of numerical simulations with measurements for the temperature of the steel surface at four locations on the top chord of an insulated truss.

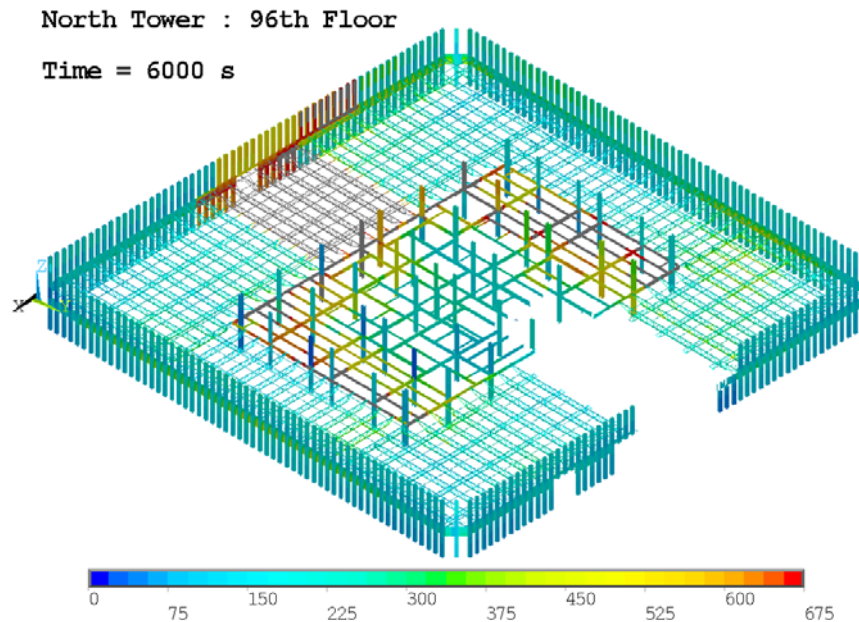
For ease of visualization, two graphic representations were developed. Figure 6–46 shows an example of the temperature map for the 96<sup>th</sup> floor of WTC 1. Severed columns and broken floor segments are not shown. Figure 6–47 shows a similar map for the 81<sup>st</sup> floor of WTC 2.

**Figure 6–46. Temperatures (°C) on the columns and trusses of the 96<sup>th</sup> floor of WTC 1 at 6,000 s after aircraft impact, Case B.**

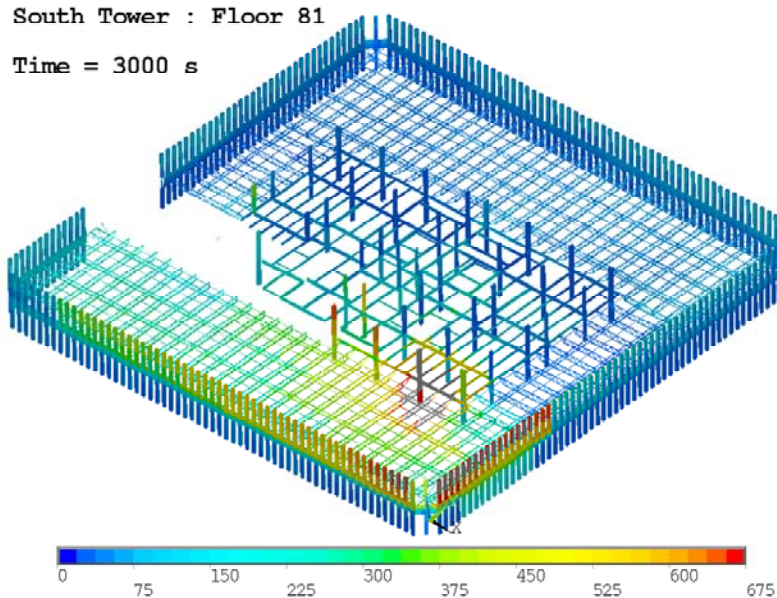
**Figure 6–47. Temperatures (°C) on the columns and trusses of the 81<sup>st</sup> floor of WTC 2 at 3,000 s after aircraft impact, Case D.**

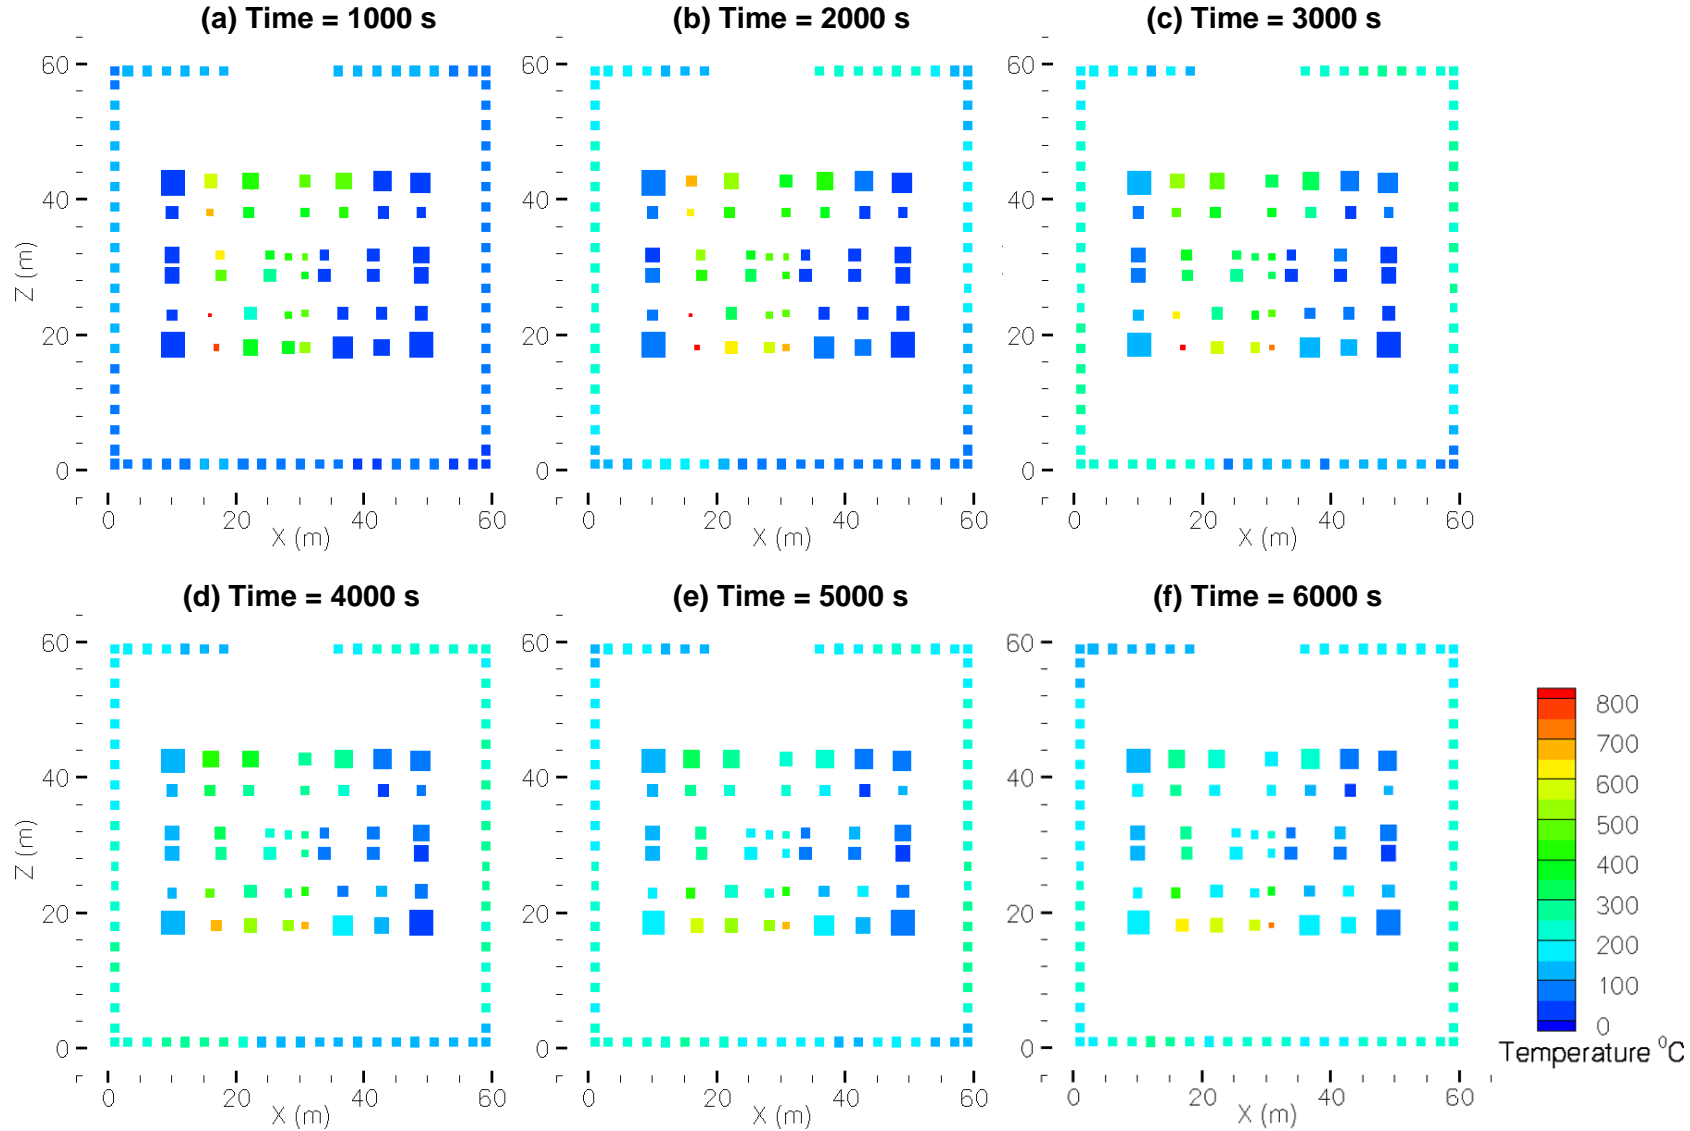
A third visualization tool was animation of the evolving temperatures of the columns. Frames from an example, again of the 96<sup>th</sup> floor of WTC 1, Case A, are shown in Figure 6–48. The size of the square representing a column represents its yield strength. Columns may have been heated when the fire was nearby and then cooled after the local combustibles were consumed.

Figure 6–48. Frames from animation of the thermal response of columns on the 96<sup>th</sup> floor of WTC 1, Case A.
